HISTORIC RESOURCES INVENTORY - BUILDING AND STRUCTURES

Building Name (Common) 82 State Street
 Building Name (Historic) William T. Dowd House
 Street Address or Location 82 State Street
 Town/City Guilford Village _____ County New Haven
 Owner(s) Whitney Thompson Jr. C/O Tracy Tomaselli Public Private

82 State Street

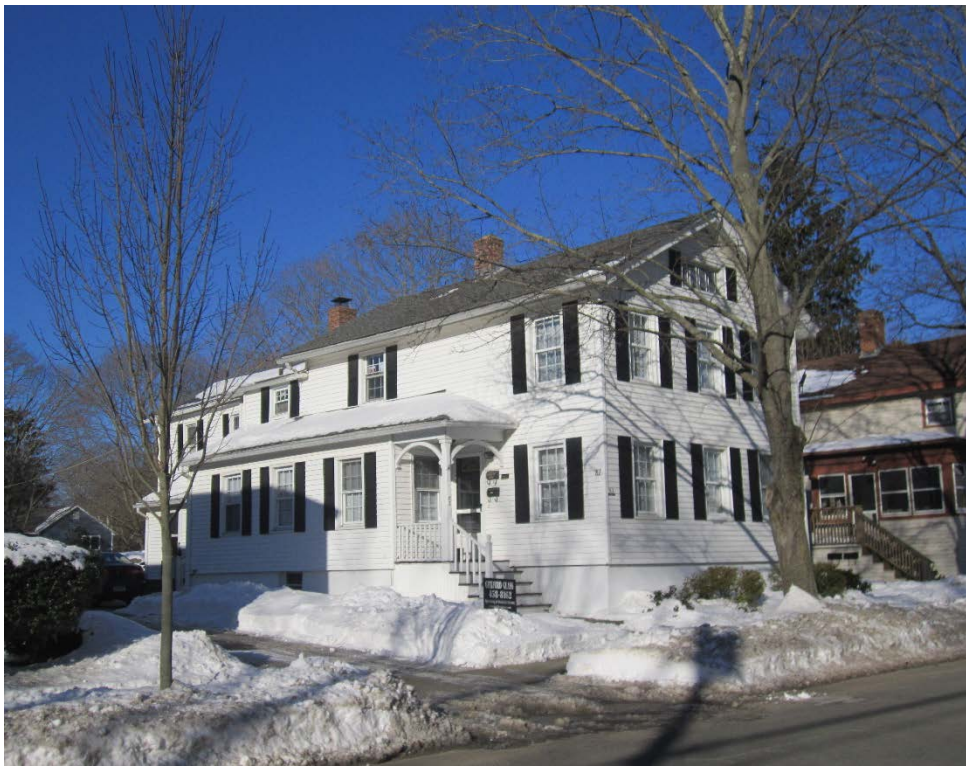
Built in 1862, this Greek Revival style building sits atop a white concrete foundation and is sheathed in white vinyl siding with black trim. The front gable roof is covered with architectural shingles and has two chimneys both on the ridgeline but one is on the main section and one is on the middle section. There is also a third section in the rear, all of them are front gabled. A twelve pane recessed rectangular window is located near the roof peak. (See Continuation Sheet)

Photographer Jordan Sorensen Date 01/31/2015
View East, camera facing west Negative on File _____
Name Jordan Sorensen Date 09/14/2015
Organization Guilford Preservation Alliance
Address PO Box 199 Guilford, CT 06437

Three six over six hung sash windows are located on both the first and second floor of the front façade. A small wing is attached to the south elevation, set back one bay, with a hipped roof. The door entry is located at the front of the wing on the south side elevation. An overhang with decorative supports and brackets covers the entryway at the top of a small stoop.
