## HISTORIC RESOURCES INVENTORY - BUILDING AND STRUCTURES

Building Name (Common) 47 Union Street  
 Building Name (Historic) Southeast Center District School  
 Street Address or Location 47 Union Street  
 Town/City Guilford Village \_\_\_\_\_ County New Haven  
 Owner(s) Paul and Tagliapietra Kockelman  Public  Private

47 Union Street

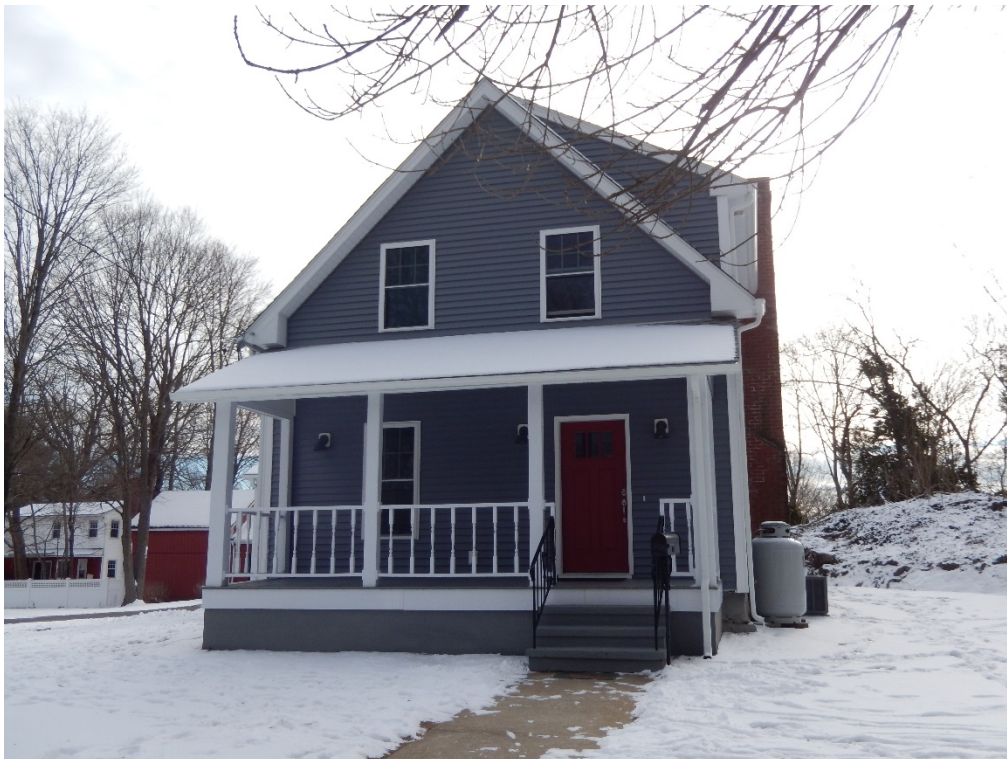
Built in 1837, this 1.5 story Vernacular style house sits atop a poured concrete foundation and is sheathed in blue vinyl siding with white trim. The front gable roof is covered in asphalt shingles and has one chimney on the west eave side. A shed dormer is located on the north west corner of the house and two gabled dormers are on the east elevation. Two six over one hung sash windows are on the second story level of the front facade. (See Continuation Sheet)

A full facade porch is on the first story with one six over one hung sash window and a red door entry. The porch has white supports and turned balusters with a shed roof above. A concrete stoop with black iron railing leads up to the porch. It should be noted, this building was extensively renovated by Portley Construction Company during September-October of 2014.
