**HISTORIC RESOURCES INVENTORY:**  
Buildings & Structures

**SURVEY OF GUILFORD, NEW HAVEN COUNTY, 06437**  
June-December 1981

1. ADDRESS 72 Union Street  
(map 40, lot 109)
2. NAME  
(historic) Henry B. Dolph  
NAME  
(common)
3. USE  
(historic) Private house  
USE  
(present) Private house and  
apartment
4. IF MOVED, WHEN AND FROM WHERE:

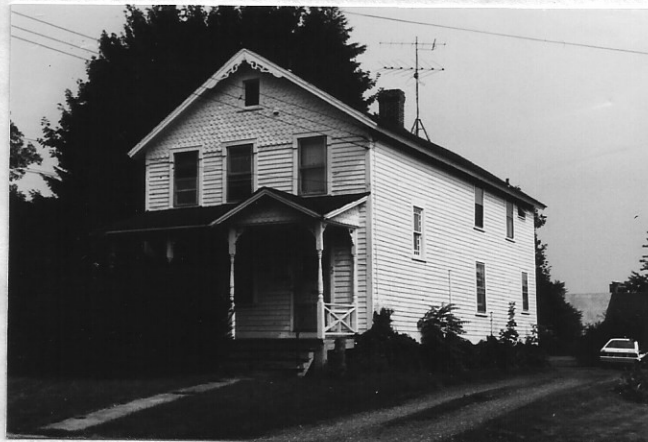
5. ARCHITECT
6. DATE c1905
7. ALTERATIONS  
Rear shed addition; window sash.

**BUILDER**  
**STYLE** Vernacular Queen Anne

8. NOTABLE FEATURES  
Decorative shingles in gable and on porch gable; curvilinear bargeboards in gable peak; stained glass stair window; turned porch posts with brackets.
9. ARCHITECTURAL-HISTORICAL  
The use of shingles in the gable simplified window hoods and curvilinear bargeboards in the peak of the gable dress up this modest two story house. A shed roof porch extends along the front of this narrow three bay house with a gable placed over the entrance. Decorative shingles are placed in the porch gable and the roof is supported by turned posts with brackets.
