HISTORIC RESOURCES INVENTORY - BUILDING AND STRUCTURES

Building Name (Common) 120 Water Street
 Building Name (Historic) Martin Linskey House
 Street Address or Location 120 Water Street (Formerly 126)
 Town/City Guilford Village _____ County New Haven
 Owner(s) F.J. Corsini II Inc. Public Private

Style of building Folk Victorian Date of Construction 1895 (Helander)

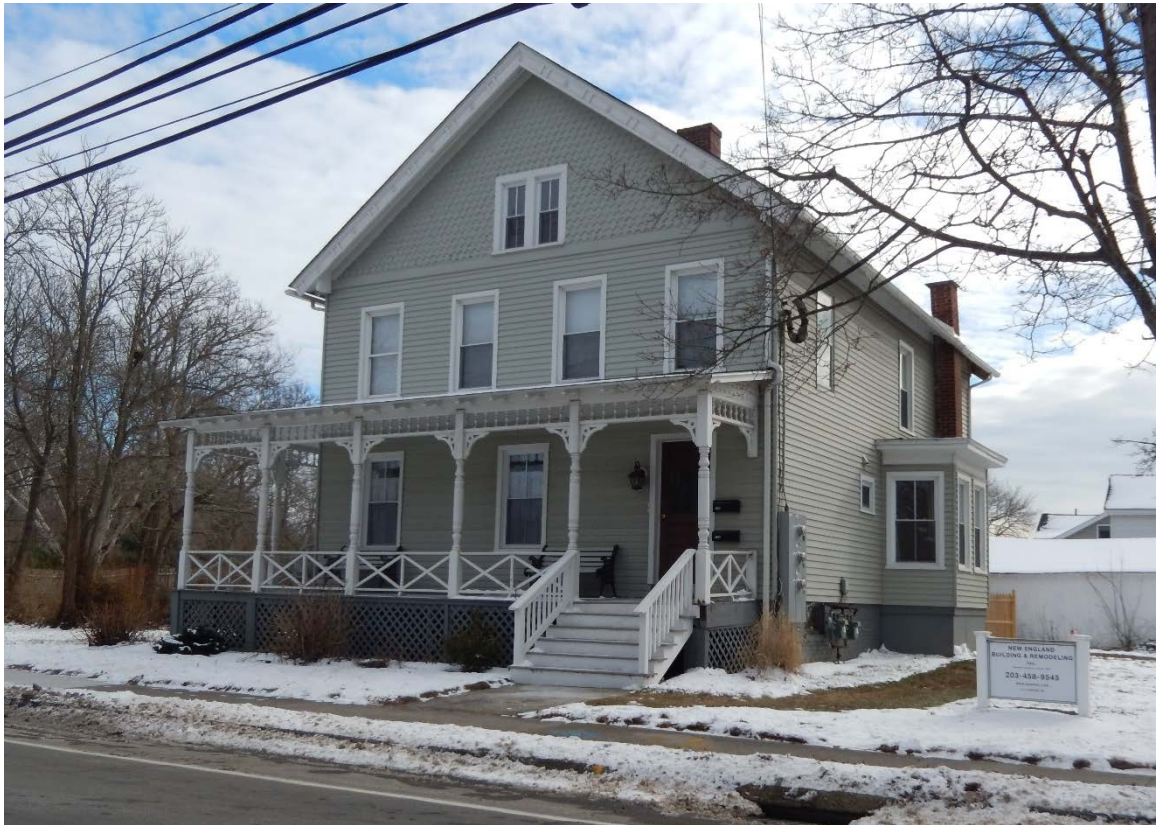
This two and half story Folk Victorian style house built in 1895 sits atop a brick and poured concrete foundation and is sheathed in light green aluminum siding, with patterned shingles in the pediment. The front gable roof is covered in asphalt shingles and has two chimneys, one on the rear ridgeline and one on the east elevation eave wall. A pair of two thin two over two hung sash windows are located near the roof peak. (See Continuation Sheet)

Four one over one hung sash windows are on the second story level. Two more windows, both two over two hung sash windows are located on the first floor with a door entry at the east end of the front façade. A one story white decorative porch, with turned spindle supports and lace-like braces, covers the front of the façade. Gray latticework is underneath the porch and a wooden stoop leads up to it.
