HISTORIC RESOURCES INVENTORY:
 Buildings & Structures

SURVEY OF GUILFORD, NEW HAVEN COUNTY, 06437
 June-December 1981

1. ADDRESS 468 Water Street
(map 26, lot 9)
2. NAME
(historic)
NAME
(common)
3. USE
(historic)
USE
(present) Private house
4. IF MOVED, WHEN AND FROM WHERE:

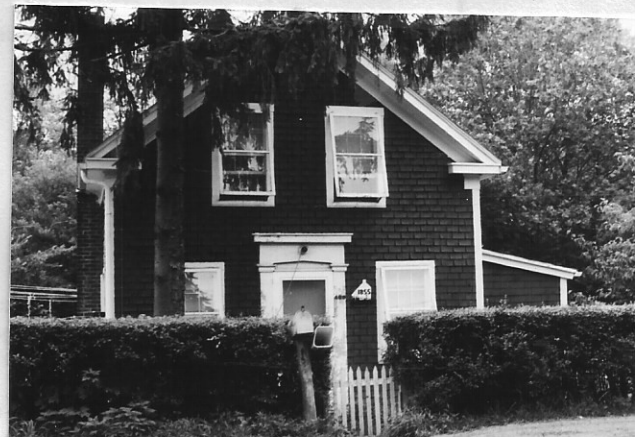
5. ARCHITECT
6. DATE c1860
- BUILDER
STYLE Greek Revival
7. ALTERATIONS
Rear addition; new clapboards on front facade 1982; shingles on side.

8. NOTABLE FEATURES
Front door in the center of the facade; doorway with an entablature (with a slight curve in the frieze), and plain pilasters.

9. ARCHITECTURAL-HISTORICAL
The windows in the second floor gable end of this small house are larger than they could have been if its builder had followed tradition in lining them up over the first-floor windows. The slight bend of the doorway entablature shows a Greek Revival form already under the influence of a later Victorian style. In a setting where the ruins of a concrete trolley overpass loom large, this small house with its garden, hedge, and picket gate are picturesque.
G. Ross is identified as the owner of this property on the 1868 Map. No further data on Ross has been found in the indices of the Guilford Library.
