HISTORIC RESOURCES INVENTORY:
Buildings & Structures

SURVEY OF GUILFORD, NEW HAVEN COUNTY, 06437
June-December 1981

1. ADDRESS 65 Water Street
(map 32, lot 39)
2. NAME
(historic) Elias Cadwell
NAME
(common)
3. USE
(historic)
USE
(present) Private house
4. IF MOVED, WHEN AND FROM WHERE:
Moved from Boston Street in 1958

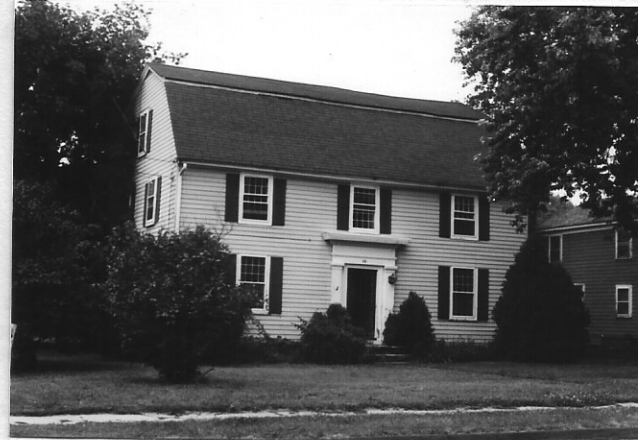
5. ARCHITECT
6. DATE 1763 BUILDER
STYLE Colonial
7. ALTERATIONS
Rear gambrel roof ell; siding; 6/6 sash; Greek Revival doorway.
House had two chimneys in its Whitfield location.
8. NOTABLE FEATURES
8/12 sash (second floor); 12/12 sash (first floor); stone
foundation; gambrel roof.
