HISTORIC RESOURCES INVENTORY:
Buildings & Structures

SURVEY OF GUILFORD, NEW HAVEN COUNTY, 06437
June-December 1981

1. ADDRESS 118 Whitfield Street
(map 40, lot 169)
2. NAME
(historic) Andrew Parmelee
NAME
(common)
3. USE
(historic) Private house
USE
(present) Store and apartment
4. IF MOVED, WHEN AND FROM WHERE:

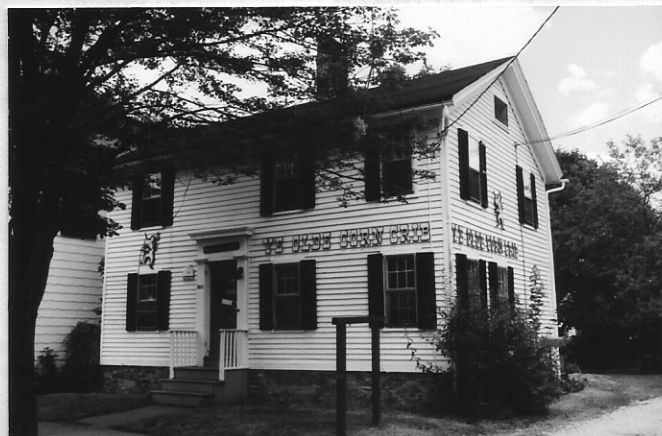
5. ARCHITECT
6. DATE 1726
- BUILDER
STYLE Colonail Period
7. ALTERATIONS
19th century alterations - roof changed; window openings; window sash; Greek Revival doorway with pilasters and an entablature; brick chimney.
8. NOTABLE FEATURES
Rubble stone foundation.

9. ARCHITECTURAL-HISTORICAL
Said to have been built in 1726, this house shows little of its original structure. The 19th century alterations, however, created a unified house with Greek Revival features--an excellent example of a modest home successfully transformed to meet the taste of a later period.
