HISTORIC RESOURCES INVENTORY:
Buildings & Structures

SURVEY OF GUILFORD, NEW HAVEN COUNTY, 06437
June-December 1981

1. ADDRESS 15 Whitfield Street
(map 39, lot 102)
2. NAME
(historic) George Fowler
NAME
(common)
3. USE
(historic)
USE
(present) Real Estate office and
apartment
4. IF MOVED, WHEN AND FROM WHERE:

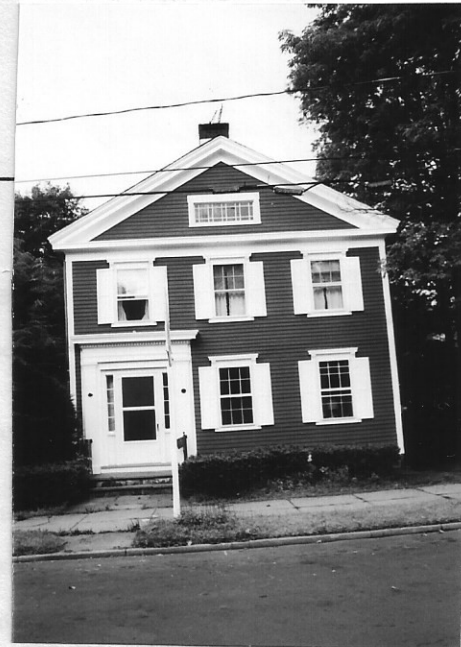
5. ARCHITECT
6. DATE 1829
- BUILDER
STYLE Greek Revival
7. ALTERATIONS
Railing on front steps.

8. NOTABLE FEATURES
Heavy cornice; bracketed window "hoods".
9. ARCHITECTURAL-HISTORICAL
The generous width of the door framing, with sidelights and pilasters, draws attention to the entrance. The windows, highlighted by shutters and bracketed hoods, balance the strength of the doorway to form an early Greek Revival front. This building is of an uncommon style for houses in the Village, which experienced little in-town building during the second quarter of the 19th century.
