HISTORIC RESOURCES INVENTORY:
Buildings & Structures

SURVEY OF GUILFORD, NEW HAVEN COUNTY, 06437
June-December 1981

1. ADDRESS 186-188 Whitfield
(map 33, lot 10)
2. NAME William Faulkner
(historic)
NAME
(common)
3. USE
(historic)
USE
(present) Double House
4. IF MOVED, WHEN AND FROM WHERE:

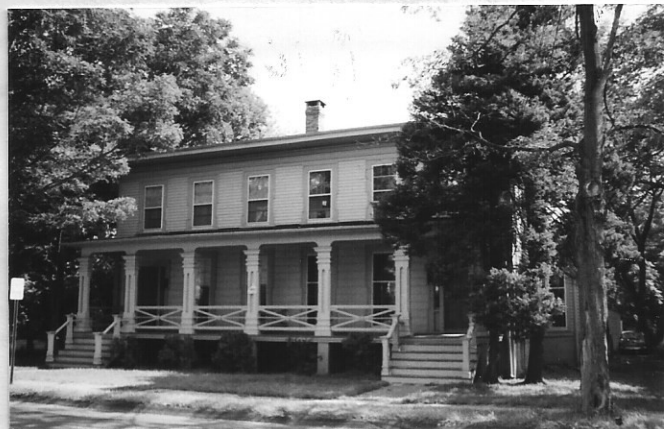
5. ARCHITECT See below
6. DATE c1850
- BUILDER
STYLE Villa Style
7. ALTERATIONS
Basement windows added under porch. Small north window replaced one of regular size when the house was bought and renovated 1975-76.

8. NOTABLE FEATURES
Broad eave with entablature below; floor-length windows on the first floor front; eared window surrounds; porch extending across the whole front, with paired steps and distinctive rail. Square channeled columns with flat moldings.

- ☒ Excellent ☐ Good ☐ Fair ☐ Poor ☐ Bad
