FOR OFFICE USE ONLY									
Town No.:					Site No.: 433				
UTM									
QUAD:									
DISTRICT					IF NR SPECIFY				
<input type="checkbox"/> S	<input type="checkbox"/> NR				<input type="checkbox"/> Actual	<input type="checkbox"/> Potential

SURVEY OF GUILFORD, NEW HAVEN COUNTY, 06437
June-December 1981

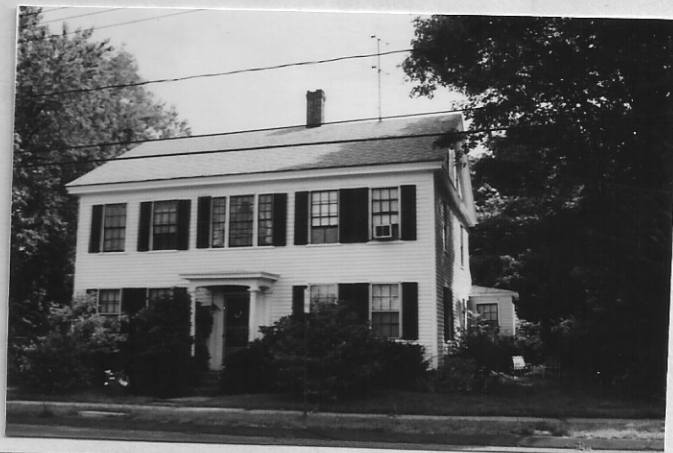
5. ARCHITECT
6. DATE c1814
- BUILDER
STYLE Federal
7. ALTERATIONS
- Two small side additions; chimney; shutters
8. NOTABLE FEATURES
- 6/6/ sash; triple, Palladian-like window; round column porch; fanlight over the door.

9. ARCHITECTURAL-HISTORICAL
A delicate entrance portico and the triple window above highlight the central symmetry of his house. It makes an important contribution to Guilford's stock of buildings from the Federal period. This one is late, built during the War of 1812, at the end of Guilford's period of maritime prosperity.
- Col. William Hart was an active member of the First Congregational Church, a deacon at one time and one of the founders of its Sunday School in 1816.
