HISTORIC RESOURCES INVENTORY:
Buildings & Structures

SURVEY OF GUILFORD, NEW HAVEN COUNTY, 06437
June-December 1981

1. ADDRESS 114 Wildrose Avenue
(map 67, lot 5)
2. NAME Roswell Redfield
(historic)
NAME
(common)
3. USE
(historic)
USE
(present) Private house
4. IF MOVED, WHEN AND FROM WHERE:

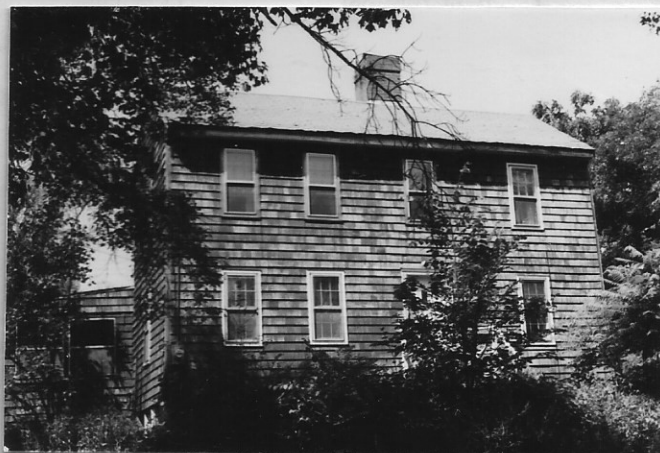
5. ARCHITECT
6. DATE 1814
- BUILDER
STYLE Federal
7. ALTERATIONS
Side addition; shingle siding; front door.
8. NOTABLE FEATURES
Overhanging eaves; boxed cornice; 2/2 floor plan; stone foundation.

9. ARCHITECTURAL-HISTORICAL
The steep grade to the street emphasizes the tall narrow form of this simple structure that holds two rooms on each floor. The house seems to have been built by Roswell Redfield in 1814 and transferred by him to Joseph Griffing November 1 of that same year. The ell on the west side may be older than the house; newspapers of 1803-4 were found in its attic, and originally it had a "Dutch" overhang like that of 68 Water Street before a new roof hid it.
