HISTORIC RESOURCES INVENTORY:
Buildings & Structures

SURVEY OF GUILFORD, NEW HAVEN COUNTY, 06437
June-December 1981

1. ADDRESS 909 Beaver Head
(map 116, lot 2)
2. NAME
(historic) General Augustus Collins
NAME
(common)
3. USE
(historic)
USE
(present) Private House
4. IF MOVED, WHEN AND FROM WHERE:

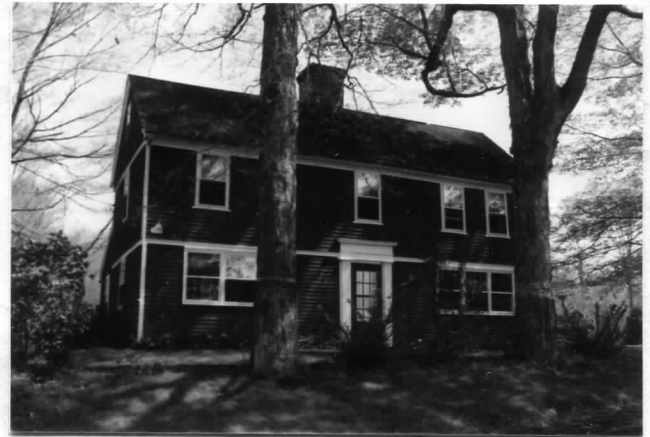
5. ARCHITECT
6. DATE 1788 written on chimney BUILDER
STYLE Colonial
7. ALTERATIONS The Greek Revival door on the Colonial facade evidently indicates a desire on the part of a later owner, probably around 1840, to keep up with the times. First floor windows on facade a modern alteration. Sash of other windows altered at various times. Later additions to rear. Aluminum ~~stone~~ sash.
8. NOTABLE FEATURES ^{STORM}
The very slight overhang on front and sides with its row of dentils all across the facade (and also over the door) is curious: are the dentils perhaps a later embellishment? Chimney appears to be original.

9. ARCHITECTURAL-HISTORICAL The Connecticut Historical Commission survey of 1972 comments: "It is suspected by local historians that this house is actually earlier than the date of 1788 on the chimney, because of the 1-room depth and shallow overhang. Chimney seems to be of appropriate size."
General Augustus Collins served in the Revolutionary army. He was a prominent public man, a magistrate for many years and served the town in nearly forty sessions of the legislature. His sister, Lorraine, married Governor Oliver Wolcott, one of the signers of the Declaration of Independence. Collins was born in 1743 and died in 1814.
