HISTORIC RESOURCES INVENTORY:
Buildings & Structures

SURVEY OF GUILFORD, NEW HAVEN COUNTY, 06437
June-December 1981

1. ADDRESS 3061 Boston Post Road
(map 83, lot 1)
2. NAME
(historic) Noah Fowler, Jr.
NAME
(common)
3. USE
(historic)
USE
(present) Private house
4. IF MOVED, WHEN AND FROM WHERE:

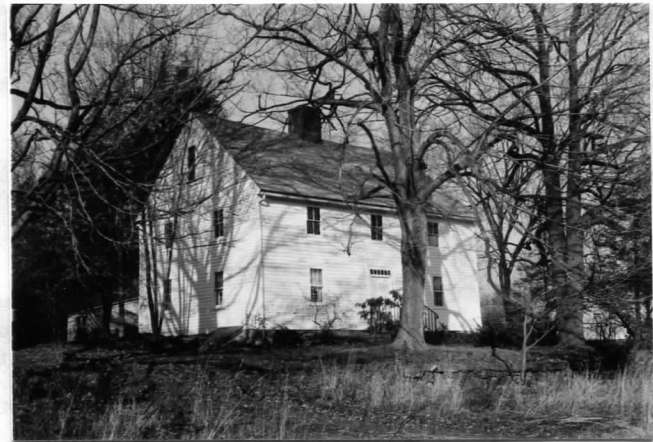
5. ARCHITECT
6. DATE See below BUILDER
STYLE Colonial
7. ALTERATIONS
Side addition later, and railing on front steps. The brick chimney is presumably a later rebuilding but probably retains its original form.
8. NOTABLE FEATURES
Overhanging eave with a moulding below; old paneled door with a six pane transom above; stone foundation.

Windows are small, the door with simple transom lights is plain, the broad expanse of the facade is divided by only three bays. This is a rugged country house, giving an impression of an older time than the comfortable last decades of the 18th century. It is also a house of tremendous presence--austere and powerful as it sits on its slight terraced elevation, set off from (con't. on next sheet)
