HISTORIC RESOURCES INVENTORY - BUILDING AND STRUCTURES

Building Name (Common) 110 Boston Street
 Building Name (Historic) David Benton House
 Street Address or Location 110 Boston Street
 Town/City Guilford Village _____ County New Haven
 Owner(s) Maryellyn Page Public Private

110 Boston Street

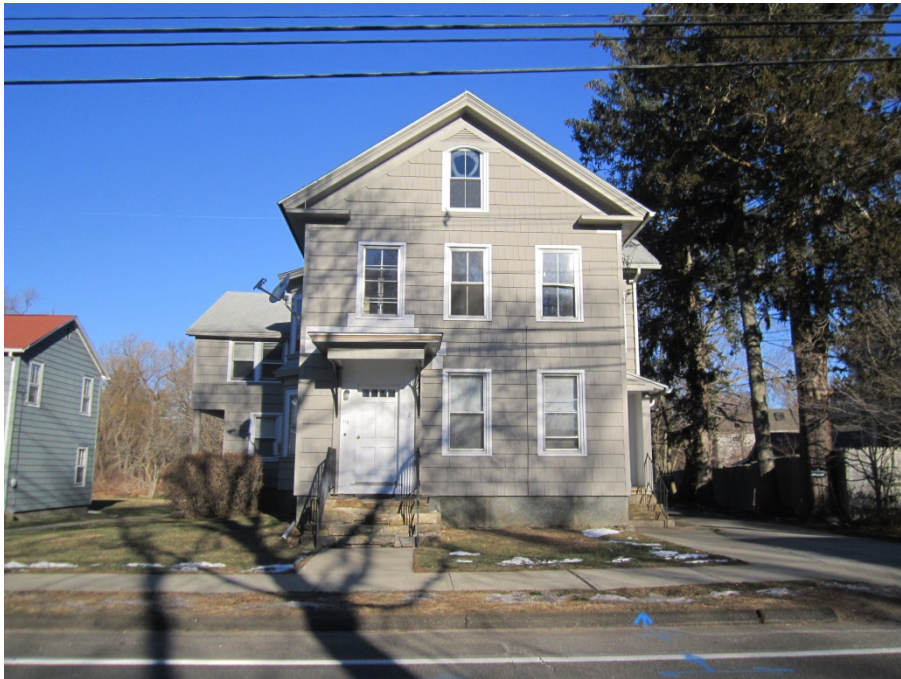
This is a two and a half story, front-gable roof house with Greek Revival features which include a simple entablature surround around the door and overhanging eaves with a broken cornice return. The house is sheathed in wood shingles, asphalt shingles cover the roof, and the foundation is of granite. The main facade faces south, and the main door is near the west corner. (see continuation sheet)

View South view, camera facing north. Negative on File _____

Above the door is a roof held up by iron brackets, and stone steps lead to the entry. Two one-over-one double-hung sash windows are to the east of the door. Above the entry, in the second story, are three two-over-two double-hung sash windows. A two-over-two double-hung sash window is in the gable-peak. The house has a small extension on the east side and two additions, one in the rear (north side elevation), and the other on the west side elevation.
