HISTORIC RESOURCES INVENTORY:
Buildings & Structures

SURVEY OF GUILFORD, NEW HAVEN COUNTY, 06437
June-December 1981

1. ADDRESS 159 Boston Street
(map 40, lot 139)
2. NAME
(historic) Charles Caldwell
NAME
(common)
3. USE
(historic)
USE
(present) Private house
4. IF MOVED, WHEN AND FROM WHERE:

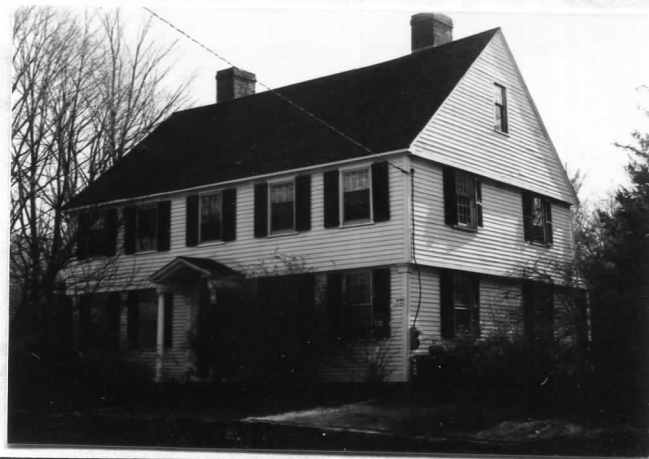
5. ARCHITECT
6. DATE c1740
- BUILDER
STYLE Colonial and Federal
7. ALTERATIONS
Historians believe the house to have been originally of the central chimney type: see below. Major fire in 1919.
8. NOTABLE FEATURES With its sharply pitched roof and hewn overhangs ornamented with carved corbels at the corners, this house bespeaks its early origin and is one of Guilford's notable survivals. Deep and massive in outline, it must have been one of the more imposing structures of its time. The present twin chimneys probably date from a re-modeling in the Federal period, sometime around 1815, at which time the dainty little porch, fanlight, and windows were presumably also added.
