HISTORIC RESOURCES INVENTORY:
 Buildings & Structures

SURVEY OF GUILFORD, NEW HAVEN COUNTY, 06437
 June-December 1981

1. **ADDRESS** 402 Boston Street
(map 48, lot 46)
2. **NAME**
(historic) Richard Bartlett
NAME
(common)
3. **USE**
(historic)
USE
(present) Private house
4. **IF MOVED, WHEN AND FROM WHERE:**

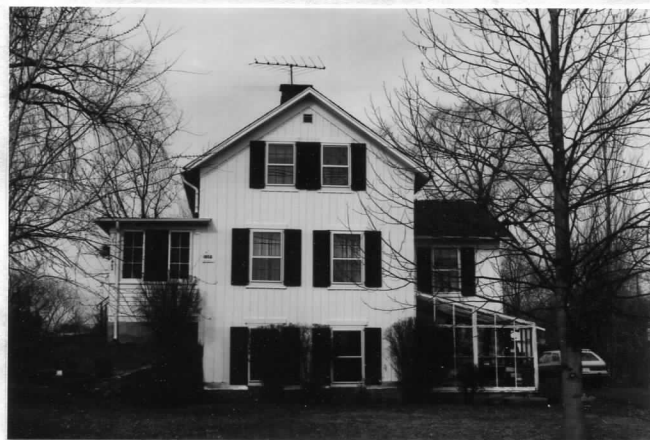
Negative 23:5A

8. **NOTABLE FEATURES**
 This building's most notable feature is its growth: see below.

9. **ARCHITECTURAL-HISTORICAL**
 This appears to be a Greek Revival house to which alot of things have happened: in recent times it has picked up a greenhouse and a glassed-in porch, earlier the ground may have been cut away in front to open up the basement and make another story. The result today is a far cry from the Greek Revival (hardly anything remains to remind us of it except the frieze under the cornice) but the narrow steep lines of the central block and the asymmetrical grouping of wings on different levels have produced a distinctive composition that has considerable character.
