HISTORIC RESOURCES INVENTORY:
 Buildings & Structures

SURVEY OF GUILFORD, NEW HAVEN COUNTY, 06437
 June-December 1981

1. **ADDRESS** 433 Boston Street
 (map 48, lot 53)
2. **NAME**
(historic) Joseph Testori
NAME
(common)
3. **USE**
(historic) 2 buildings: private
USE house with garage and
(present) apartment
4. **IF MOVED, WHEN AND FROM WHERE:**

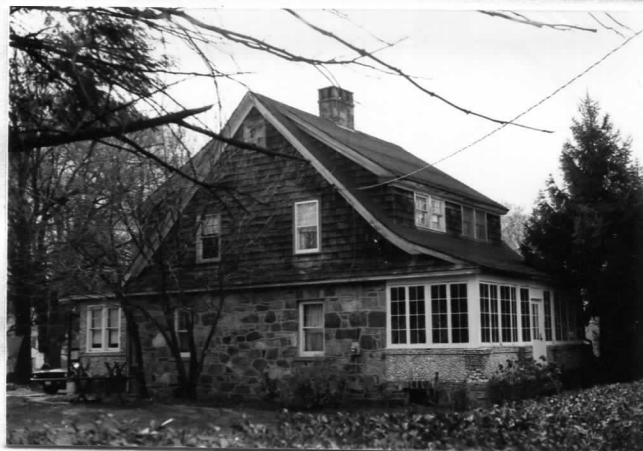
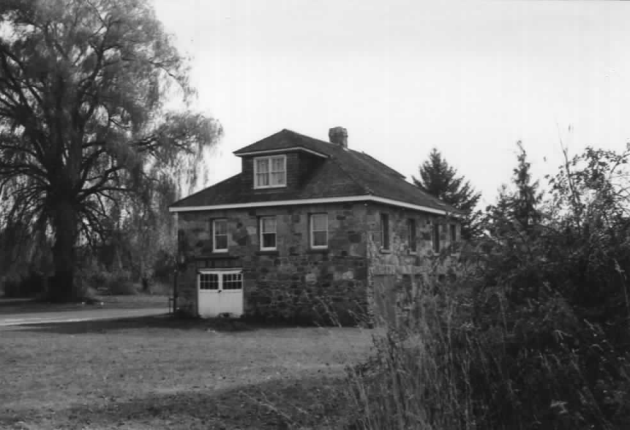
There are two buildings on the property, a small house and much larger two-story garage with apartment, both of masonry--a rarity in Guilford. Unique verandah of small white stones. On the garage, walls of random pattern defined by strong horizontals of lintels, sills, and steps of monolith granite.

Built along bungalow lines, the house is distinguished by its novel stonework: fieldstone walls with a verandah of smallwhite cobble- or beachstones (pebble work). The garage walls are laid up in a random but intricate pattern, the stones (which mix grey and pink blocks with fieldstones) becoming bigger and more regular as they rise. An example of the personal work of a local mason. The Testoris also built the row of stone houses across the street.
