**HISTORIC RESOURCES INVENTORY:**  
Buildings & Structures

**SURVEY OF GUILFORD, NEW HAVEN COUNTY, 06437**  
June-December 1981

1. ADDRESS 65 Boston Street  
(map 40, lot 148)
2. NAME  
(historic) F.A. Weld  
NAME  
(common)
3. USE  
(historic)  
USE  
(present) Private house
4. IF MOVED, WHEN AND FROM WHERE:

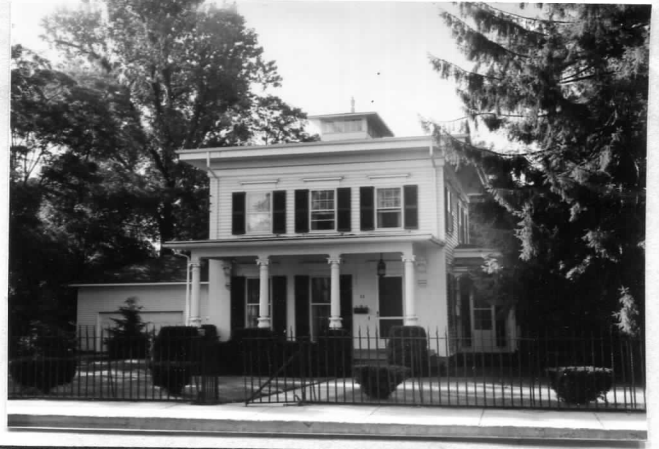
8. NOTABLE FEATURES One of Guilford's important 19th century houses and a full-fledged example of the Villa style: broad eaves with a plain frieze running around below; broad-eaved monitor on the roof, repeating in miniature the outline of the house itself; flush-boarding on the facade; projecting window-

9. ARCHITECTURAL-HISTORICAL heads and tall front windows opening onto a symmetrically placed, broadeaved porch--everything strong, square, direct, and balanced. Well preserved today even to the finial on top of the monitor (such little touches of finery too often have succumbed to the economy measures of later owners) and to the wide, four-square lot which repeats the symmetry of the house itself and provides the frame intended for it. This is one of the few buildings in Guilford that can perhaps lay claim to having been designed by Henry Austin, New Haven's well known architect. No documentation is available, but we know that William Weld, the builder, sometimes worked from Austin designs, and this house shows definite signs of Austin's influence. (cont'd. on next sheet)

Notice especially the exotic oriental columns on the porch, springing from bases carved like great overblown plants. These were one of Austin's favorite motifs, copied from a book illustrating the palaces and temples of India. For example in New Haven, see the Dana House, 24 Hillhouse Avenue, and the William Lewis house near Wooster Square (613 Chapel Street). There are numerous others.
