HISTORIC RESOURCES INVENTORY - BUILDING AND STRUCTURES

79 Boston St

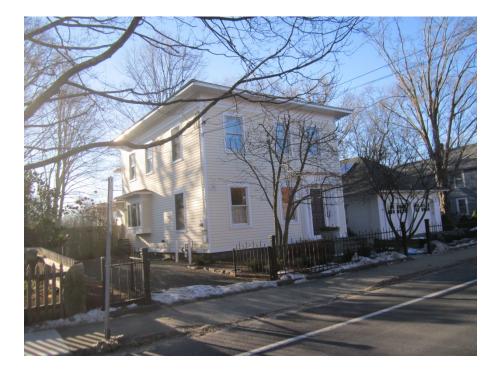
This is a two-story, hip-roof house with Greek Revival features. It is sheathed in clapboard siding and has asphalt shingles on the roof. The Greek Revival features include wide over-hanging eaves and a simple entablature door surround on the main entry which is located on the north facade. The main door is a paneled door and is flanked by four-pane side lights. Two one-over-one double-hung sash windows to the west. (see continuation sheet)

Photographer Kristen Nietering				Date 1/17/2015			
View Northeast view, camera facing southwest.				Negative on File			
Name Kristen Nietering				Date10/4/2015			
Organization Guilfo	ord Preservation A	lliance					
	99 Guilford, CT 06						
• Subsequent field e	evaluations:						
Latitude & Longitu	ıde: 41.282353, -72.	678094					
Threats to the bui	lding or site:						
🗙 None known	Highways	Vandalism	Developers	Renewal	Private		
Deterioration	Zoning	Other		Explanation
