HISTORIC RESOURCES INVENTORY:
 Buildings & Structures

SURVEY OF GUILFORD, NEW HAVEN COUNTY, 06437
 June-December 1981

1. **ADDRESS** 85 Boston Street
(map 40, lot 145)
2. **NAME**
(historic) Thomas Burgis
NAME
(common)
3. **USE**
(historic)
USE
(present) Private house
4. **IF MOVED, WHEN AND FROM WHERE:**

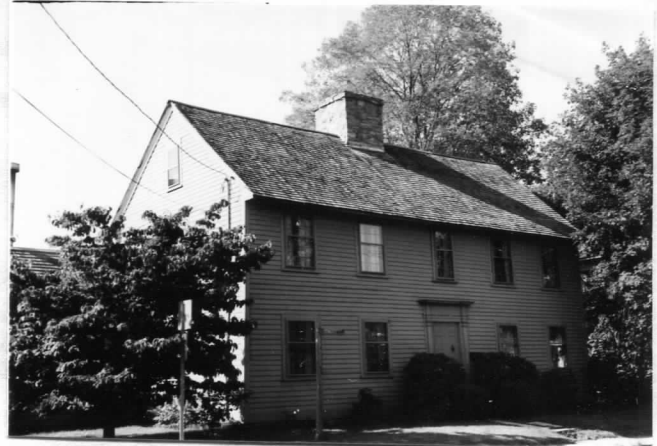
8. **NOTABLE FEATURES**
Overhanging eaves; stone chimney; eight over twelve windows; doorway with thin pilasters supporting an entablature (could be original); paneled door; stone foundation.
9. **ARCHITECTURAL-HISTORICAL**
In the midst of the growing ranks of the metallicized and plasticized historic houses of Boston Street, it is a joy to find one that is still its natural self--and a particularly early and valuable one at that. Wood clapboards, cedar shingles, a center chimney which, although evidently rebuilt, is still of stone and of the right size; 8/12 sash, an agreeable color scheme, and finally a charming Federal door make this one of the outstanding historic survivals in town.
