**HISTORIC RESOURCES INVENTORY:**  
Buildings & Structures

**SURVEY OF GUILFORD, NEW HAVEN COUNTY, 06437**  
June-December 1981

1. ADDRESS 22 Broad Street  
(map 39, lot 15)
2. NAME Reuben Stone  
(historic)  
NAME  
(common)
3. USE  
(historic)  
USE Private house  
(present)
4. IF MOVED, WHEN AND FROM WHERE:

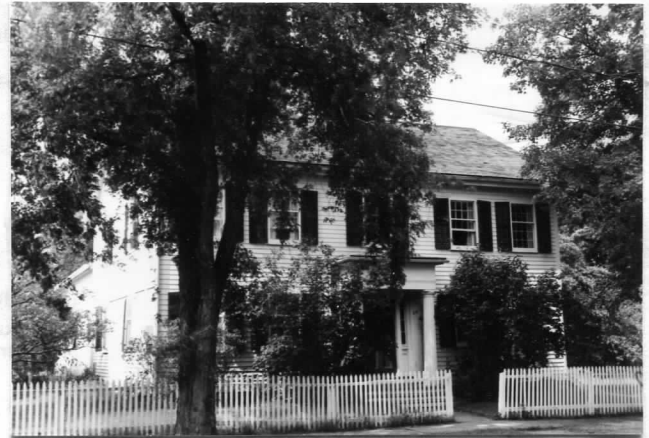
5. ARCHITECT
6. DATE 1769
7. ALTERATIONS In 1842 the roof line was altered making the roof less steep and adding an overhang; also the Greek Revival portico was added; new chimney.
8. NOTABLE FEATURES Overhanging eaves; a very slight overhang on the gable end at the first floor level; Greek Revival portico with fluted columns, wide frieze, and sidelights flank the door.

9. ARCHITECTURAL-HISTORICAL The alteration in the roof of this Colonial house changes the overall look of the house. However, close examination reveals the slight overhang on the gable is evidence of the true age of the house. The Greek Revival portico with its fluted columns is similar to a number of porticos in Guilford known to have been done by William Weld. This house and its immediate neighbors are situated behind a fine series of connecting picket fences.  
Reuben and Caleb Stone, sons of Caleb, inherited shares in the ownership of Faulkner's Island in 1761. They later sold these shares circa 1800. Reuben Stone made two trips to New Haven and one to Hartford to arrange procurement of provisions for Guilford's Revolutionary soldiers. He was reimbursed for this travel on 12 April 1779.
