**HISTORIC RESOURCES INVENTORY:**  
 Buildings & Structures

**SURVEY OF GUILFORD, NEW HAVEN COUNTY, 06437**  
 June-December 1981

1. ADDRESS 76 Broad Street  
(map 39, lot 35)
2. NAME  
(historic) Jared Leete  
NAME  
(common) Guilford Forge
3. USE  
(historic) private house  
USE  
(present) Gift shop
4. IF MOVED, WHEN AND FROM WHERE:  
Moved somewhat to west of original location

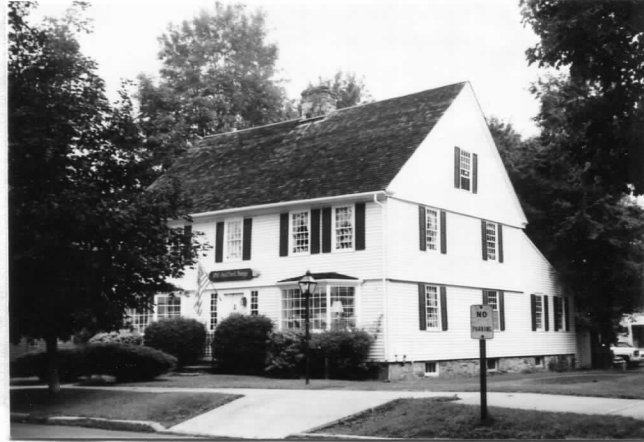
5. ARCHITECT
6. DATE c1774
- BUILDER  
STYLE Colonial
7. ALTERATIONS  
Bay windows, front steps and railing, sidelights by door. Chimney evidently rebuilt and made smaller than original. Aluminum siding.
8. NOTABLE FEATURES  
12/12 sash throughout. Overhangs. The interior has been preserved as well as possible considering its present use.
