HISTORIC RESOURCES INVENTORY:
Buildings & Structures

SURVEY OF GUILFORD, NEW HAVEN COUNTY, 06437
June-December 1981

1. ADDRESS 100 Cherry Street
(map 46, lot 59)
2. NAME
(historic) Morse Feed Store and
NAME Grain Elevator
(common)
3. USE Food Store and Grain
(historic) Elevator
USE
(present) Animal Food Production
4. IF MOVED, WHEN AND FROM WHERE:

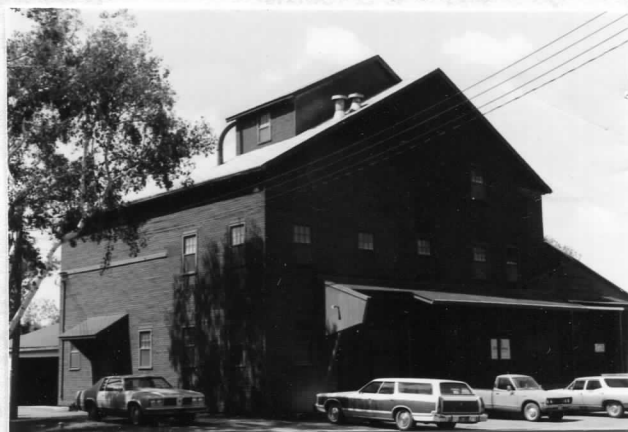
5. ARCHITECT
6. DATE 1931 BUILDER
STYLE Mill
7. ALTERATIONS
The porch roof has been cut back and posts added. The two bays on the west side and the shed roof addition replace a two story building.
8. NOTABLE FEATURES
Overhanging eaves; 6/6 windows; small brick structure to the east of the building; used to house the generator.

9. ARCHITECTURAL-HISTORICAL
This large structure was built in a straightforward manner for commercial purposes. There was no apparent attempt to include any architectural ornament. The three-story grain elevator was originally built with three bays and was connected to two smaller, previously existing buildings. The porch roof tied the three buildings together. At a later date, possibly c1940, the center of the three buildings was replaced by an additional two bays on the west end of the three story portion and a two story shed roof addition now connects to the one story office building. The porch roof, originally supported by wires, was cut back and support posts added.
