HISTORIC RESOURCES INVENTORY:
 Buildings & Structures

SURVEY OF GUILFORD, NEW HAVEN COUNTY, 06437
 June-December 1981

1. **ADDRESS** 77 Chimney Corner Circle
(map 1, lot 24)
2. **NAME**
(historic) H. Drusilla Mitchell
NAME
(common)
3. **USE**
(historic) Summer Cottage 1902-1976
USE
(present) Private house 1976 -
4. **IF MOVED, WHEN AND FROM WHERE:**

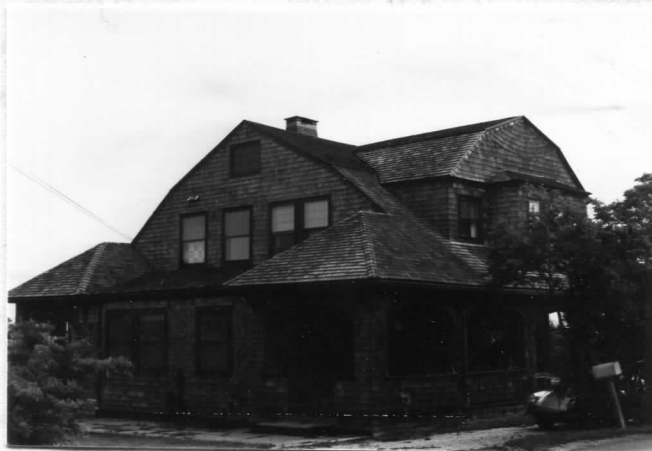
GLFD'S NEG. 19:26

5. **ARCHITECT** Davis, Brooks & Crosby of
6. **DATE** Hartford/ 1902
- BUILDER**
- STYLE** Shingle style
7. **ALTERATIONS**
 Remodeled in 1976 for year round use to the designs of J.V. Richter of New Haven. This was sensitively done, disturbing the exterior as little as possible, thus preserving the unique style and character of the original house.
8. **NOTABLE FEATURES**

9. **ARCHITECTURAL-HISTORICAL**
 This shingle style cottage was built for Mrs. G.H. Mitchell. The form of the house, with its low, crossed gambrel roofs and deep porches, admirably suits the exposed site on Long Island Sound.

The exterior configuration of the house is largely determined by the roof plan - the crossed gables are of different heights; the angle of the hip in each roof gable is shallow. The roof plan is elaborated by dormers and low porch roofs which give the house a ground hugging silhouette.
