**HISTORIC RESOURCES INVENTORY:**  
 Buildings & Structures

**SURVEY OF GUILFORD, NEW HAVEN COUNTY, 06437**  
 June-December 1981

1. **ADDRESS** 295 Clapboard Hill Road  
 (map 75, lot 33)
2. **NAME**  
 (historic) William A. Dudley  
**NAME**  
 (common)
3. **USE**  
 (historic)  
**USE** Private house  
 (present)
4. **IF MOVED, WHEN AND FROM WHERE:**

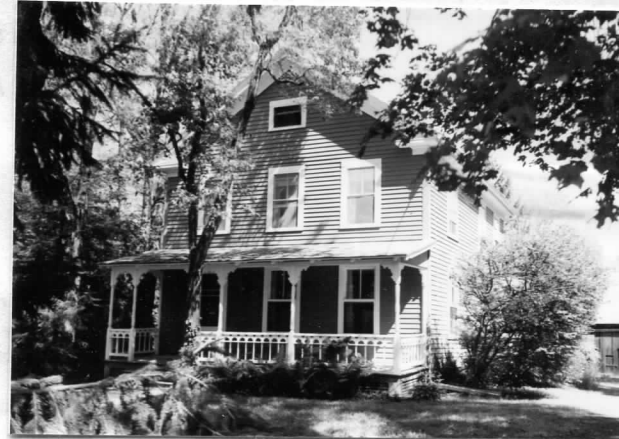
5. **ARCHITECT**
6. **DATE** 1896 **BUILDER**  
**STYLE** Queen Anne
7. **ALTERATIONS**  
 Rear addition.
8. **NOTABLE FEATURES**

9. **ARCHITECTURAL-HISTORICAL**  
 A staunch example of rural Guilford's conservatism. Except for the porch and the sharper pitch and projection of the roof there is not a great deal to distinguish this house of the 1890s from a Greek Revival house of fifty years before. It is the basic American 19th century farmhouse, dressed up with a new bib and tucker. The porch rail is exceptionally fine.
