HISTORIC RESOURCES INVENTORY:
 Buildings & Structures

SURVEY OF GUILFORD, NEW HAVEN COUNTY, 06437
 June-December 1981

1. **ADDRESS** 610 County Road
(map 105, lot 16)
2. **NAME**
(historic) Rossiter
NAME
(common)
3. **USE**
(historic)
USE
(present) Private house
4. **IF MOVED, WHEN AND FROM WHERE:**

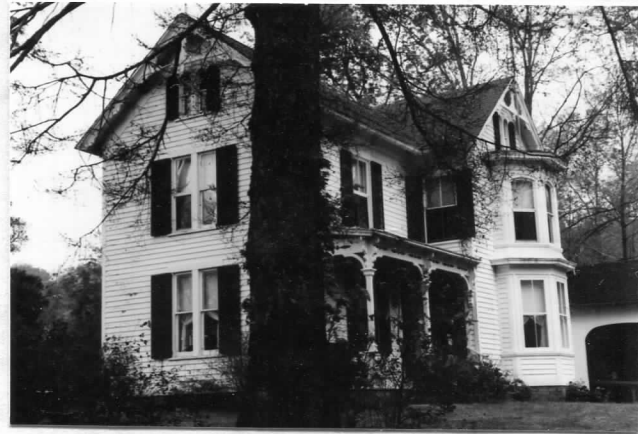
5. **ARCHITECT**
6. **DATE** c1880 **BUILDER**
STYLE Queen Anne
7. **ALTERATIONS**

8. **NOTABLE FEATURES**
 Overhanging eaves and raking; very ornate bargeboard with scroll work and pendant; two-story bay window; paired arched windows in the gables; porch with square columns scroll work and brackets; original front door; stone foundation.
9. **ARCHITECTURAL-HISTORICAL**
 One of the well preserved houses in North Guilford dating from the last quarter of the nineteenth century. This house appears to retain most of ornamental trim. The scroll work on the porch and the scroll and bracket work in the gables are particularly worthy of note.
