HISTORIC RESOURCES INVENTORY:
Buildings & Structures

SURVEY OF GUILFORD, NEW HAVEN COUNTY, 06437
June-December 1981

1. ADDRESS 149 Denison Drive
(map 72, lot 12-12)
2. NAME
(historic) Dwight Tavern
NAME
(common)
3. USE Tavern
(historic)
USE Private house
(present)
4. IF MOVED, WHEN AND FROM WHERE:
Moved from Warren, Mass.
on the Boston Post Road in 1980.

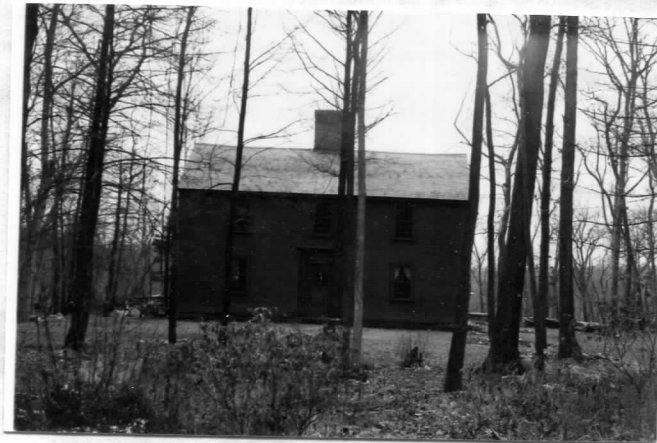
8. NOTABLE FEATURES
Two over two floor plan; 12/12 sash; 4/4 sash in the gable; projecting window frames; doorway with recessed panel pilasters; crown moulding with dentil-like trim, six pane transom (with bull's eye glass), and a paneled door; stone block foundation.

9. ARCHITECTURAL-HISTORICAL
This Massachusetts house has been reconstructed in Guilford. It has been well sited on its lot and presents an interesting contrast to locally built houses of the same period. The Massachusetts house appears broader with more space between the windows. The window framing and other detail work also contribute to the sense that this is not a local house.
The house was built in 1746 by Colonel Simeon Dwight and was located on the Boston Post Road in Warren, Massachusetts. Dwight was also involved in building a grist mill and an iron furnace in Warren. The Dwight Tavern was visited by many prominent people; a local Warren historical record details a visit from George Washington.
