# HISTORIC RESOURCES INVENTORY - BUILDING AND STRUCTURES

GENERAL INFORM							
Building Name (Comm	on) 90 Duck Hol	e Road					
Building Name (Histori	c) Andrew Jacks	son Dud	ley House				
Street Address or Locat	ion 90 Duck Ho	e Road					
Town/City Guilford		Villa	ge		County Nev	v Haven	
Owner(s) George Gos	ss II and Helene	and Ed	win Dirck			Public	X Private
PROPERTY INFOR	RMATION						
Present Use: Resident	ial: single dwelli	ng					
Historic Use: Resident	tial: single dwell	ing					
Accessibility to public	: Exterior visible	e from pu	ublic road?X	Yes No			
Interior accessible?							
Style of building Folk V	/ictorian			Date o	of Construct	ion <u>c. 1857 (</u> ł	Helander)
Material(s) (Indicate use							
X Clapboard	Asbestos Sidi	ng	Brick	Wood Shin	gle	Asphalt S	iding
Fieldstone	Board & Batt	en	Stucco	Cobblestor	ne	Aluminun	n Siding
Concrete (Typ	e	_)	Cut Stone	е ( Туре	)	Other	
Structural System							
🗙 Wood Frame	Post & Bear	m [	Balloon	Load bearing	masonry	Structur	al iron or steel

90 Duck Hole Rd

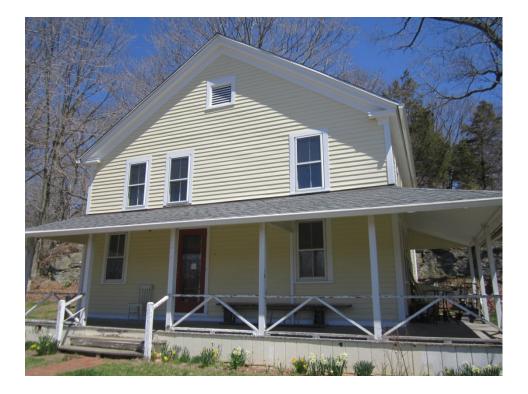
This is a two-story Folk Victorian style dwelling with an attic and a front-gable roof. The house is sheathed in clapboard siding, the roof is covered in asphalt shingles, and the foundation is of brick and stone. The eaves of the roof have a slight overhang and return cornices. The three-bay facade faces south, and the main entry is on this side. (See continuation sheet)

Photographer Kristen Nietering				Date		
$\widetilde{\mathrm{View}}$ Southwest view of the house, camera facing northeast.				Negative on File		
Name Kristen Nietering				Date 10/8/2015		
Organization Guilfo		lliance				
Address 199 PO Bo	ox Guilford, CT 06	6437				
• Subsequent field ev	raluations:					
Latitude & Longitud	de: 41.304675, -72.	659703				
Threats to the build	ding or site:					
🗙 None known	Highways	Vandalism	Developers	Renewal	Private	
Deterioration	Zoning	Other		Explanation _

It is reached by wood stairs with wood railings, and is protected by the open porch which has a wide overhanging roof supported by slender wood posts. Fenestration consists of two-over-two double-hung sash windows. An addition is attached to the north elevation of the house.
