**HISTORIC RESOURCES INVENTORY:**  
 Buildings & Structures

**SURVEY OF GUILFORD, NEW HAVEN COUNTY, 06437**  
 June-December 1981

1. **ADDRESS** 109 Dunk Rock Road  
(map 45, lot 4)
2. **NAME**  
*(historic)* John Hotchkiss  
**NAME** (Hodgkins)  
*(common)*
3. **USE**  
*(historic)*  
**USE** Private house  
*(present)*
4. **IF MOVED, WHEN AND FROM WHERE:**

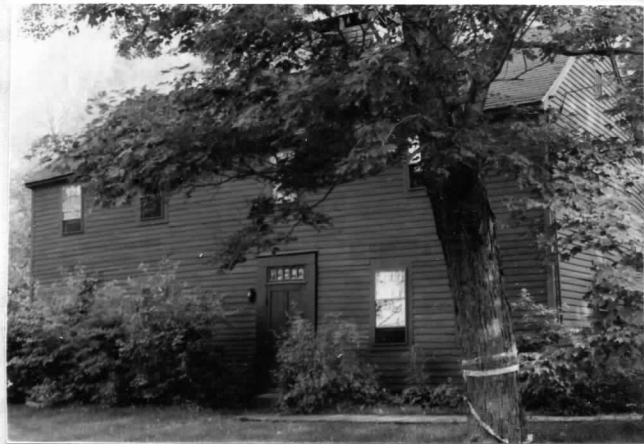
8. **NOTABLE FEATURES**  
 Asymmetrical facade; moulding under eaves; small window openings; 6/6 sash (second floor); 8/12 sash (first floor); four pane gable window in the gable; plain door and window frames; five pane transom; large stone block foundation.

9. **ARCHITECTURAL-HISTORICAL**  
 This is one of several houses built in Guilford in the mid 18th century with irregular features. The front facade is asymmetrical with an uneven alignment of windows on the right side. The doorway on this house appears to retain its original form; many other houses of this period have had Greek Revival doorways added. This house is situated close to the road which is narrow and lined with many old stonewalls.
