HISTORIC RESOURCES INVENTORY - BUILDING AND STRUCTURES

Building Name (Common) Erastus Dudley House
 Building Name (Historic) Erastus Dudley House
 Street Address or Location 2631 Durham Road
 Town/City Guilford Village _____ County New Haven
 Owner(s) Neil Dinerman Public Private

Erastus Dudley House/2631 Durham Rd

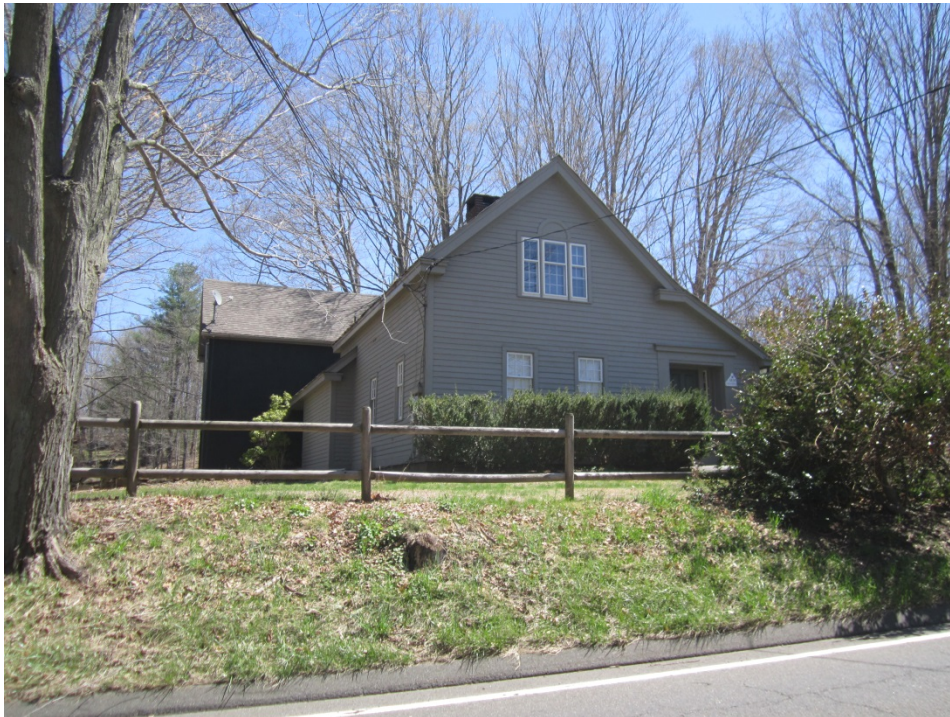
This is a two-story Greek Revival style dwelling with a saltbox-roof. The house is sheathed in clapboard siding and the roof is covered in asphalt shingles. The eaves of the roof have a slight overhang and return cornices. The three-bay façade faces west, and the main entry is on this side. It is reached by wood and stone steps, and is set within the façade. The entry includes a simple door surround, and sidelights flank each side of the door. (See continuation sheet)

Photographer Kristen Nietering Date 4/26/2015
View West view of house, camera facing east. Negative on File _____
Name Kristen Nietering Date 10/12/2015
Organization Guilford Preservation Alliance
Address 199 PO Box Guilford, CT 06437

Fenestration consists of six-over-nine and four-over-six double-hung sash windows. A decorative arch is found above the windows on the second story. A brick chimney protrudes from the ridgeline of the roof. An addition is attached to the east elevation of the house.
