HISTORIC RESOURCES INVENTORY:
 Buildings & Structures

SURVEY OF GUILFORD, NEW HAVEN COUNTY, 06437
 June-December 1981

1. **ADDRESS** 700 Durham Road
 (map 85, lot 18)
2. **NAME**
(historic)
NAME
(common)
3. **USE**
(historic)
USE
(present) Private house
4. **IF MOVED, WHEN AND FROM WHERE:**

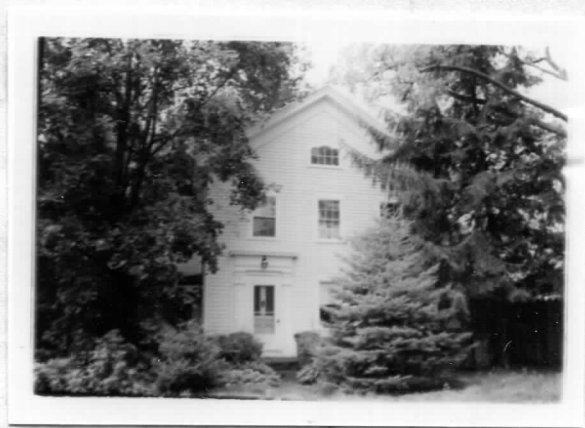
5. **ARCHITECT**
6. **DATE** c1870 **BUILDER** Greek Revival
STYLE
7. **ALTERATIONS**
 Rear addition, side dormer, side door.

8. **NOTABLE FEATURES**
 Boxed cornice with returns; wide frieze; 6/6 sash; eight pane gable window with a three arched frame; Greek Revival doorway with entablature and pilasters with a recessed diamond pattern in the base; stone foundation.

9. **ARCHITECTURAL-HISTORICAL**
 Although this house follows the basic Greek Revival formula, which had been familiar in the New Haven area since at least the 1830s (gable end to street with three-bay facade, off-center entrance, and Doric doorway), here the outline is steeper, testifying to a desire for higher ceilings and for more usable space in the attic. It also testifies to a later date than the true Greek Revival style, one that has begun to be seduced by the verticality of the on-coming Italianate style--arriving in Guilford, as usual, a bit on the late side and being accepted only with great caution. The odd little scalloped window in the gable tells the story in a nutshell: the classic rectangular, horizontal window of the traditional Greek Revival is here making a nervous marriage with the tall paired arched windows typical of the Italiante.
