HISTORIC RESOURCES INVENTORY:
Buildings & Structures

SURVEY OF GUILFORD, NEW HAVEN COUNTY, 06437
June-December 1981

1. ADDRESS 38 Fair Street
(map 39, lot 20)
2. NAME
(historic) Rev. Daniel Brewer
NAME
(common)
3. USE
(historic)
USE
(present) Private house
4. IF MOVED, WHEN AND FROM WHERE:

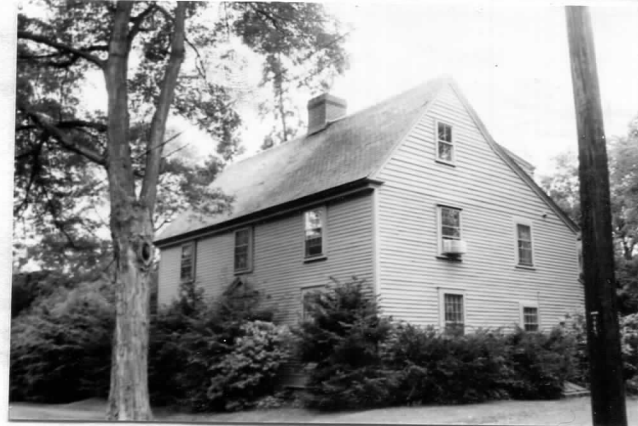
5. ARCHITECT
 6. DATE 1772
 7. ALTERATIONS
- Large dormer on rear roof, also leanto roof line raised; shed addition in rear; slate "fish scale" roof (1890s); chimney rebuilt; pediment doorway.
8. NOTABLE FEATURES 8/12 sash in second story and 12/12 sash in the first story; a band of cut away circles decorating the cornice; protruding window frames in the front portion of the house; water shed covering the sill.

9. ARCHITECTURAL-HISTORICAL Even though the roof line of this house has been altered, the building retains its historic character and has features not commonly found in other 18th century houses in Guilford such as the projecting window frames and the "water shed" board above the foundation. House built by the Fourth Church and Society of Guilford as a parsonage for the Rev. Daniel Brewer. Brewer lived there for several years but was then dismissed. He had embraced the beliefs of the Sandemanians and this was unacceptable to his congregation.
