**HISTORIC RESOURCES INVENTORY:**  
Buildings & Structures

**SURVEY OF GUILFORD, NEW HAVEN COUNTY, 06437**

1. ADDRESS 52 Fair Street  
(map 39, lot 22)
2. NAME  
(historic) Noah Hodgkin, Jr.  
NAME  
(common)
3. USE  
(historic)  
USE  
(present) Private house
4. IF MOVED, WHEN AND FROM WHERE:

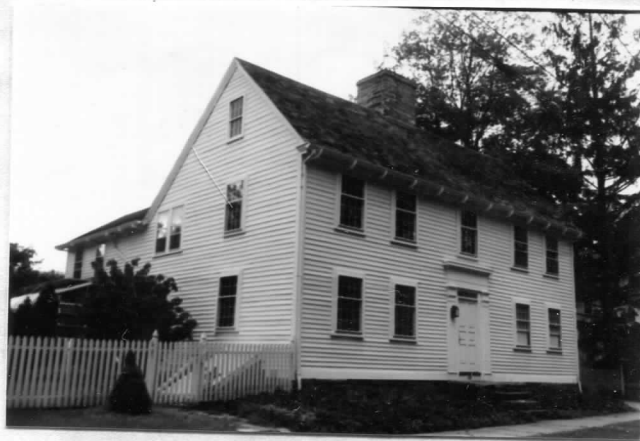
5. ARCHITECT
6. DATE 1770 BUILDER STYLE Colonial
7. ALTERATIONS  
Side fenestration; rear ell; wood gutters; Greek Revival doorway.
8. NOTABLE FEATURES  
8/12 sash except the gable window (6/6); wide board covering the sill of the house.

9. ARCHITECTURAL-HISTORICAL  
This Colonial house has a five bay facade and a center chimney. The simple form of the house accentuates the wide sill board, and the wide window frames. The Greek Revival doorway, a later alteration, has an extremely broad entablature. This house is a fine example of 18th century Guilford architecture and an integral part of the outstanding streetscape on Fair Street.
