HISTORIC RESOURCES INVENTORY:
 Buildings & Structures

SURVEY OF GUILFORD, NEW HAVEN COUNTY, 06437
 June-December 1981

1. ADDRESS 53 Fair Street
(map 39, lot 26)
2. NAME James Monroe
(historic)
NAME
(common)
3. USE
(historic)
USE
(present) Private house, apartment
4. IF MOVED, WHEN AND FROM WHERE:

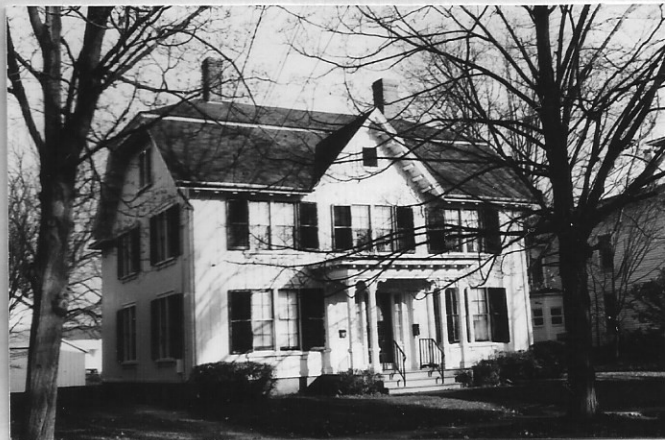
5. ARCHITECT
6. DATE c1860
7. ALTERATIONS Vent in gable window.

BUILDER
STYLE Gothic Revival

8. NOTABLE FEATURES
 Jerkinhead roof shape; board and batten siding; double grouped windows; overhanging eaves with brackets; porch original; door with sidelights.

A fine example of Gothic Revival architecture; a style not well represented in Guilford. This house is one of two Gothic houses on Fair Street, and part of an outstanding grouping of 18th and 19th century houses.
