HISTORIC RESOURCES INVENTORY:
 Buildings & Structures

SURVEY OF GUILFORD, NEW HAVEN COUNTY, 06437
 June-December 1981

1. ADDRESS 63 Fair Street
Map 39, Lot 25
2. NAME James Monroe
(historic)
NAME
(common)
3. USE
(historic)
USE
(present) Private house
4. IF MOVED, WHEN AND FROM WHERE:

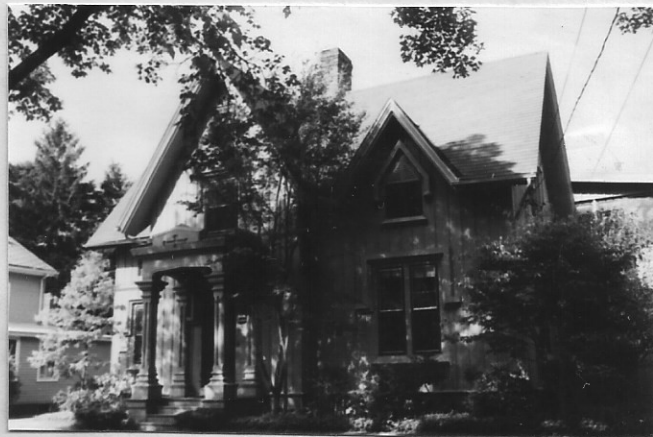
5. ARCHITECT
6. DATE c1850
- BUILDER STYLE Gothic Revival
7. ALTERATIONS
Substantial addition to the rear southside; screened in porch first floor; room on second floor; solar panels; Fenestration altered on the rear ell.
8. NOTABLE FEATURES
Board and batten siding, wide over hanging eaves; 6/6 sash. Carriage house at rear with board and batten siding decorative bargeboards; quatrefoil window in gable

9. ARCHITECTURAL-HISTORICAL
This is an outstanding example of the Gothic Revival style. The illusion of stone is achieved by the porch parapet and the heavy hood-molds. "With its strong Puritan background and Colonial heritage, Guilford was not easily seduced by the picturesque fantasies of the Gothic cottages so popular elsewhere from the 1840's on." This house was built by James Monroe who also built 53 Fair Street.
