HISTORIC RESOURCES INVENTORY:
 Buildings & Structures

SURVEY OF GUILFORD, NEW HAVEN COUNTY, 06437
 June-December 1981

1. ADDRESS 73 Fair Street
 Map 46, Lot 32
2. NAME
 (historic) James Norton
 NAME
 (common)
3. USE
 (historic)
 USE
 (present) Private house
4. IF MOVED, WHEN AND FROM WHERE:

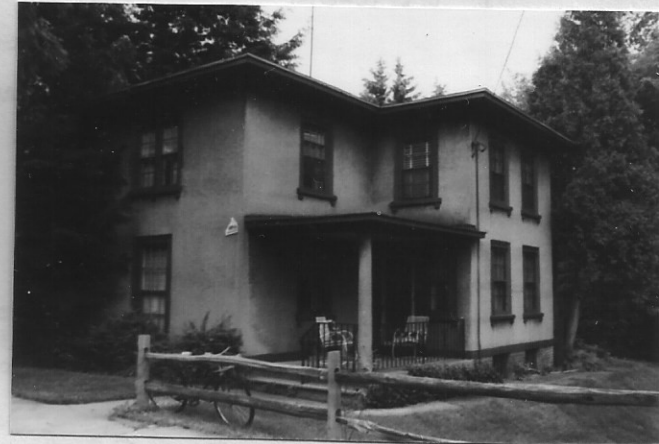
5. ARCHITECT
 6. DATE 1856
 7. ALTERATIONS
- porch; and first floor window on front of house

8. NOTABLE FEATURES wide overhanging eaves; modestly decorative window sills; one double window with 4/4 sash on the second floor front. other windows are 6/6 sash; tall first floor window on front; brick foundation.
9. ARCHITECTURAL-HISTORICAL This two story Italianate house was built in 1856 for John Norton. A photograph taken in 1911 shows the house stuccoed. Since 1911 the porch and first floor window on front of house have undergone alterations. The porch base was wooden and a smaller turned post supported a very slightly pitched roof. Ground floor window opened onto a balconette and had a canopy over it (shutters covered the opening in 1911 photo and does not reveal whether it was a window or a door). There was matching scroll work under the canopy and porchroof. All shutters have been removed since 1911 photo.
