HISTORIC RESOURCES INVENTORY:
Buildings & Structures

SURVEY OF GUILFORD, NEW HAVEN COUNTY, 06437
June-December 1981

1. ADDRESS 90 Fair Street
(map 46, lot 37)
2. NAME
(historic) Wm. Griffing, Russell, or
NAME D. Redfield
(common)
3. USE
(historic)
USE Private house
(present)
4. IF MOVED, WHEN AND FROM WHERE:

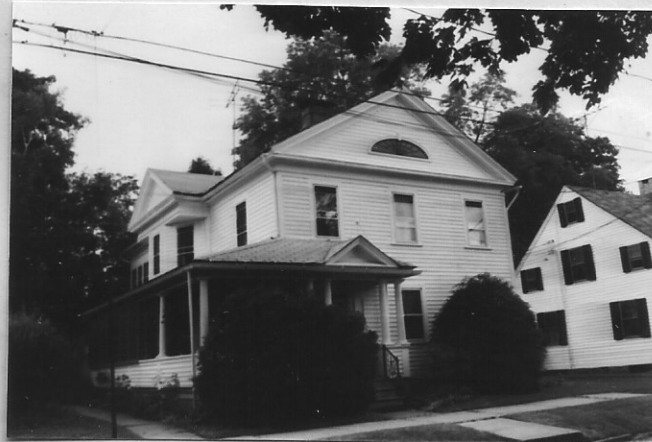
5. ARCHITECT
6. DATE 1833 BUILDER
STYLE Federal
7. ALTERATIONS
Wrap around porch; beveled sided "wing" on the south side; windows rectangular bay on the north side (alteration c1900).
8. NOTABLE FEATURES
Fanlight; cut glass side window (c1900); full pediment.

This three-bay Federal house has undergone early alterations, yet the front facade still retains most of its original character. An elliptical window, which appears to have its original glass and muntins is placed in a full pedimented gable.
