**HISTORIC RESOURCES INVENTORY:**  
 Buildings & Structures

**SURVEY OF GUILFORD, NEW HAVEN COUNTY, 06437**  
 June-December 1981

1. **ADDRESS** 28 Graves Avenue  
(map 40, lot 20)
2. **NAME**  
*(historic)* James H. Cook  
**NAME**  
*(common)*
3. **USE**  
*(historic)*  
**USE** Apartments  
*(present)*
4. **IF MOVED, WHEN AND FROM WHERE:**

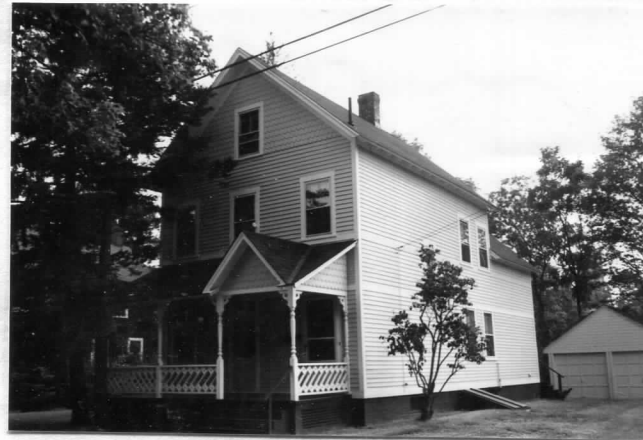
5. **ARCHITECT**
6. **DATE** c1890 **BUILDER STYLE** Queen Anne
7. **ALTERATIONS**  
 No apparent exterior alterations.

8. **NOTABLE FEATURES**  
 Overhanging eaves with visible rafters; fish scale shingles in the gable; porch and under south side windows; stained glass in the stairway window; delicate, decorative porch; brick foundation.
9. **ARCHITECTURAL-HISTORICAL**  
 Delicate woodwork and shingling, like that of the porch and gable of this house, are typical features of the Queen Anne style in this house. The porch railing here enhances a house that is an important part of the streetscape.
