# HISTORIC RESOURCES INVENTORY - BUILDING AND STRUCTURES

Building Name (Common) 14 High Street  
 Building Name (Historic) Lucius Dudley House  
 Street Address or Location 14 High Street  
 Town/City Guilford Village \_\_\_\_\_ County New Haven  
 Owner(s) Roman and Rochelle Kowalski  Public  Private

Style of building Greek Revival Date of Construction 1870 (Helander)

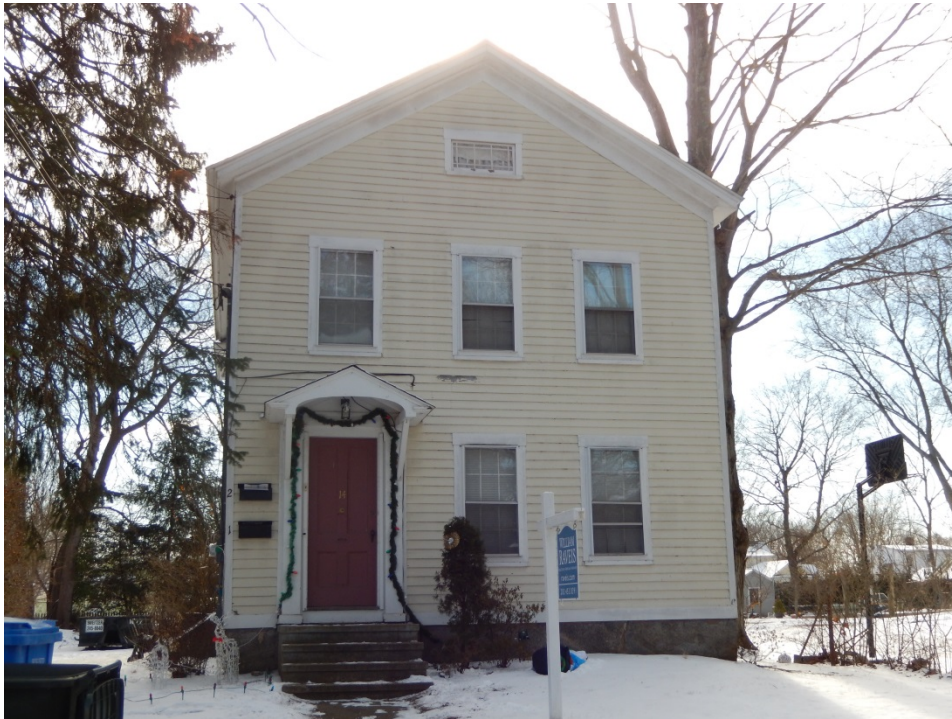
This is a two-story Greek Revival style dwelling with an attic and a front-gable roof with slightly overhanging eaves. The house is vernacular in style and sheathed in clapboard siding. The roof is covered in asphalt shingles and the foundation is made of stone. The three-bay façade faces north, and the main entry is on this side. It is reached by stone steps and is protected from the elements by a gable-roof that is supported by slender brackets. (See continuation sheet)

Photographer Kristen Nietering Date 1/31/2015  
View North view of the house, camera facing south. Negative on File \_\_\_\_\_  
Name Kristen Nietering Date 10/13/2015  
Organization Guilford Preservation Alliance  
Address 199 PO Box Guilford, CT 06437
