HISTORIC RESOURCES INVENTORY:
 Buildings & Structures

SURVEY OF GUILFORD, NEW HAVEN COUNTY, 06437
 June-December 1981

1. **ADDRESS** 17 High Street
 (map 33, lot 73)
2. **NAME**
(historic) Elisha Hart
NAME
(common)
3. **USE**
(historic)
USE
(present) Private house
4. **IF MOVED, WHEN AND FROM WHERE:**

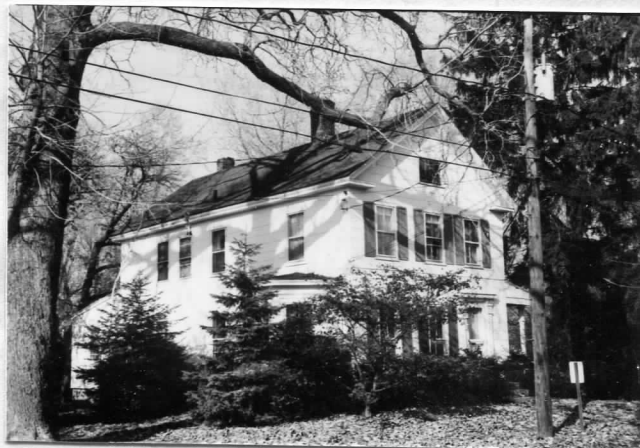
5. **ARCHITECT**
6. **DATE** 1889 **BUILDER** John C. Norton
STYLE Greek Revival/Italianate
7. **ALTERATIONS**
 Siding; concrete steps.
8. **NOTABLE FEATURES**
 Boxed cornice with returns; bay window on the side; 2/2 sash;
 entrance with two recessed panel pilasters and a small entablature.
9. **ARCHITECTURAL-HISTORICAL**

This house has some features of the style of Guilford's antebellum houses; cornice with returns, a rectangular gable window, and a doorway with pilasters and an entablature are all present here, though in versions of the late 19th century.
