**HISTORIC RESOURCES INVENTORY:**  
Buildings & Structures

**SURVEY OF GUILFORD, NEW HAVEN COUNTY, 06437**  
June-December 1981

1. ADDRESS 24 High Street  
(map 33, lot 76)
2. NAME  
(historic) George Hand  
NAME  
(common)
3. USE  
(historic)  
USE  
(present) Private house
4. IF MOVED, WHEN AND FROM WHERE:

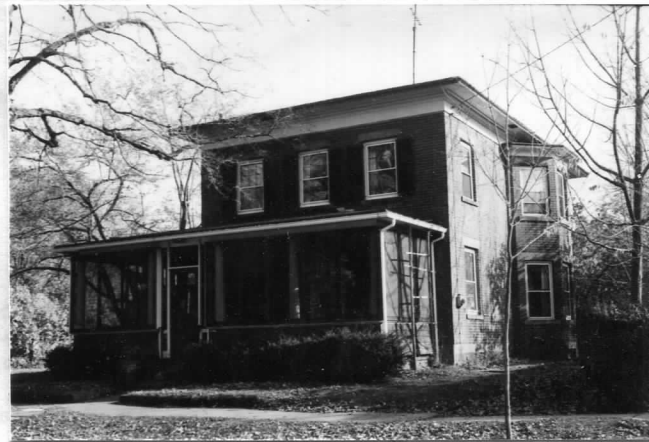
8. NOTABLE FEATURES  
Overhanging eaves with a moulding below; wide frieze; two story bay window; stone string course above the cellar windows; mark in the brick of the original column around the doorway; flat stone lintels and sills.

The broad overhang of the flat roof of this house complements its rectangular shape. That shape is enlivened by a two-story bay window and a large porch, which appears to be a later addition. Stone lintels and sills highlight the windows. It is one of the few brick houses in Guilford.
