**HISTORIC RESOURCES INVENTORY:**  
 Buildings & Structures

**SURVEY OF GUILFORD, NEW HAVEN COUNTY, 06437**  
 June-December 1981

1. **ADDRESS** 27 High Street  
(map 33, lot 71)
2. **NAME**  
(*historic*) Andrew Jackson  
**NAME**  
(*common*)
3. **USE**  
(*historic*)  
**USE**  
(*present*) Private house
4. **IF MOVED, WHEN AND FROM WHERE:**

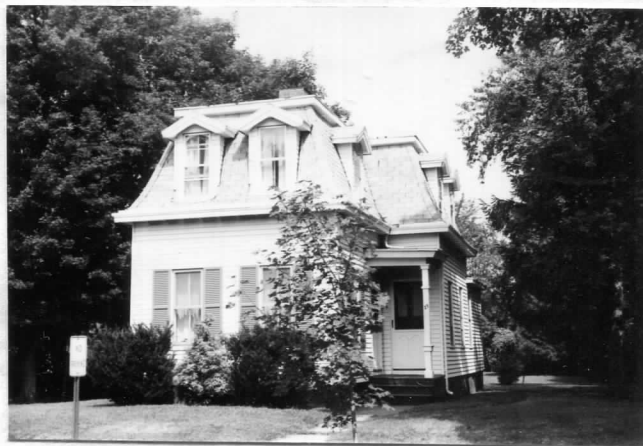
5. **ARCHITECT**
6. **DATE** c1872
- BUILDER**  
**STYLE** Second Empire
7. **ALTERATIONS**  
Siding; roofing material; 2/2 windows.

8. **NOTABLE FEATURES**  
Large block stone foundation; mansard roof.

Although one does see a number of mansard roofs in Guilford, this is the only instance of a one story house with such a roof. The entire house is small in scale and quite unique. The house appears today much as it does in the 1881 Birdseye view of Guilford.
