# HISTORIC RESOURCES INVENTORY - BUILDING AND STRUCTURES

Building Name (Common) 28 High Street  
 Building Name (Historic) W. T. Wilcox House  
 Street Address or Location 28 High Street  
 Town/City Guilford Village \_\_\_\_\_ County New Haven  
 Owner(s) Marlene Schwartz and Jeffrey Babbin  Public  Private

Style of building Greek Revival and Italianate Date of Construction 1850 (Helander)

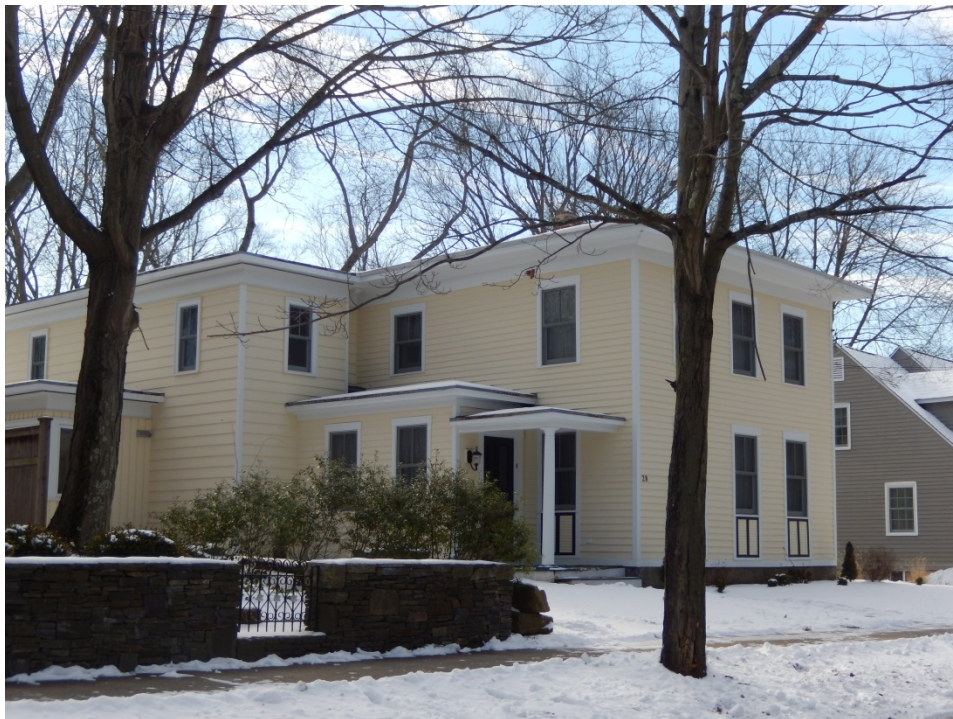
This is a two-story dwelling with a hip-roof that has overhanging eaves. The house is Greek Revival and Italianate in style and sheathed in clapboard siding. The roof is covered in asphalt shingles and the foundation is made of stone. The three-bay façade faces north, and the main entry is in a vestibule attached to this elevation. It is reached by wood steps and is protected from the elements by a hip-roof that is supported by a Doric column. (See continuation sheet)

Photographer Kristen Nietering Date 1/21/2015  
View North view of the house, camera facing south. Negative on File \_\_\_\_\_  
Name Kristen Nietering Date 10/22/2015  
Organization Guilford Preservation Alliance  
Address 199 PO Box Guilford, CT 06437

The Greek Revival features include the overhanging eaves, the symmetrical façade, the wide fascia board, and molding on the corners and bottom of the house. Fenestration consists of two-over-one double-hung sash windows. Below the first story windows on the façade are decorative features, allowing for one to imagine the window extending to the foundation, a feature often found on Italianate style houses. Another feature of Italianate houses found here is the hip-roof. A large addition is on the south elevation of the house.
