HISTORIC RESOURCES INVENTORY - BUILDING AND STRUCTURES

Building Name (Common) 46 High Street
 Building Name (Historic) Charles N. Rossiter House
 Street Address or Location 46 High Street
 Town/City Guilford Village _____ County New Haven
 Owner(s) Jos Pantalone III and Victoria Daehnke Public Private

46 High Street

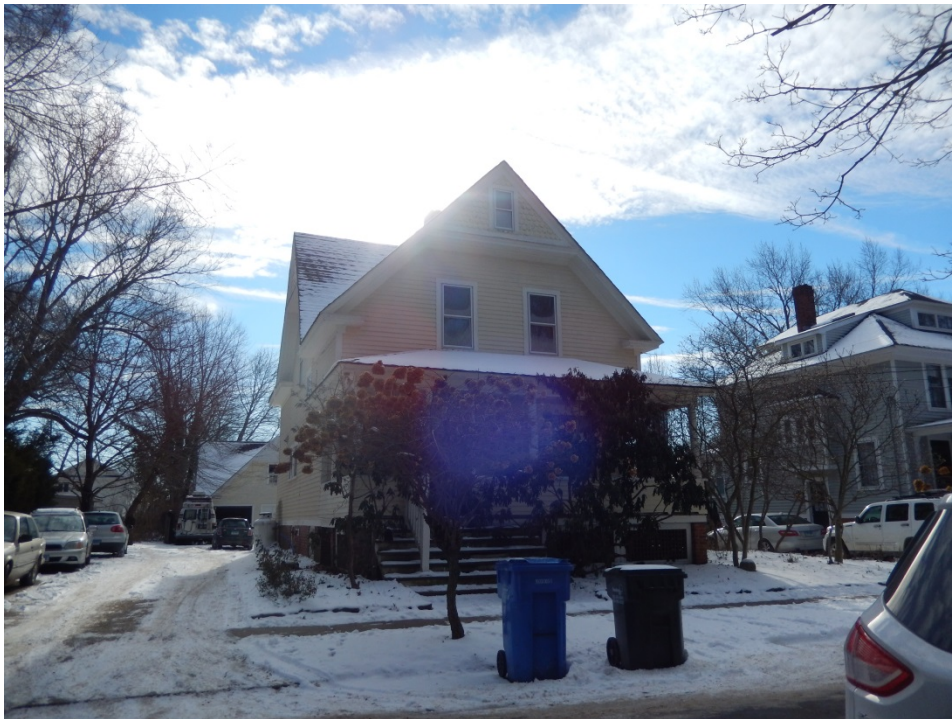
Photographer Kristen Nietering Date 1/21/2015
View North view of the house, camera facing south. Negative on File _____
Name Kristen Nietering Date 10/18/2015
Organization Guilford Preservation Alliance
Address 199 PO Box Guilford, CT 06437

A tree obscures the view of the façade of the house. However, what is visible is a wide porch off the façade that is reached by stone steps with a wood railing. The hip-roof over the porch is supported by Doric style columns. Fenestration consists of one-over-one double-hung sash windows. The Queen Anne style features include the fish scale shingles in the gable peak and the wide porch. It also has some Greek Revival features which include the cornice returns and the Doric style columns supporting the porch roof.
