HISTORIC RESOURCES INVENTORY:
Buildings & Structures

SURVEY OF GUILFORD, NEW HAVEN COUNTY, 06437
June-December 1981

1. ADDRESS 66 High Street
(map 32, lot 60)
2. NAME
(historic) Guilford Enterprise Company
NAME
(common) Clinipad Corporation
3. USE Manufacturing
(historic)
USE Manufacturing
(present)
4. IF MOVED, WHEN AND FROM WHERE:

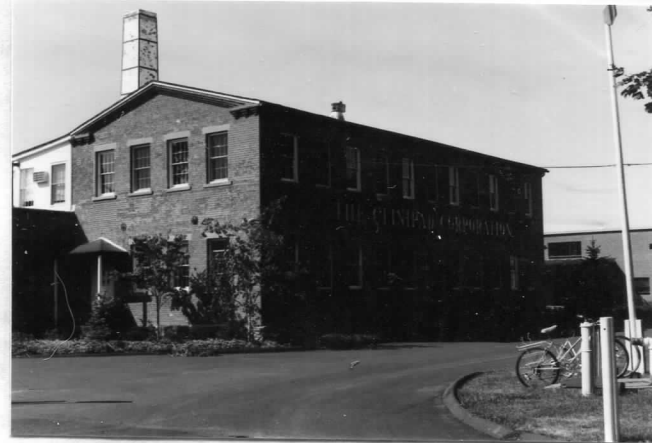
5. ARCHITECT
6. DATE c1886
- BUILDER STYLE Industrial
7. ALTERATIONS
Several additions to the rear; side door.

8. NOTABLE FEATURES
Rear brick ell on the south side (original); corbeled brick along the eave line and in the gable; stone lintels; 8/8 sash (probably new); remains of tie rods.

9. ARCHITECTURAL-HISTORICAL
This site has long been associated with manufacturing in Guilford; a brass factory and lock works began here in 1850. It was the first of a series of companies that, before the end of the 19th century, manufactured school furniture, "vegetable ivory" goods, novelties, hubs, spokes, and wheels.
The brick building now on the site seems to be one built for the Guilford Enterprise Company after their older building burned down in May 1884. The Company, in addition to working with "vegetable ivory" (celluloid?), was incorporated to manufacture and sell goods of wood, ivory, metal, composition, or rubber.
The main building is a gable-roofed two-story brick block four bays deep and eleven bays wide. Stone lintels and brick corbels add their restrained decorative touch. Numerous additions to the rear have enlarged the space (cont'd. on next sheet)

for manufacturing. They all respect the integrity of the main brick building, which stands in front of them. It is good evidence of the light industry that has contributed to the town's economy and diversity. Its scale makes it a fine neighbor at the corner of two streets of modest houses, South Fair and High.
