**HISTORIC RESOURCES INVENTORY:**  
Buildings & Structures

**SURVEY OF GUILFORD, NEW HAVEN COUNTY, 06437**  
June-December 1981

1. ADDRESS 173 Highwoods Drive  
(map 85, lot 17A-8)
2. NAME  
(historic) Elisha Pitkin House  
NAME  
(common)
3. USE  
(historic)  
USE  
(present) Private house
4. IF MOVED, WHEN AND FROM WHERE:  
Moved from East Hartford  
Taken down 1952-1953. Re-erected 1954-55

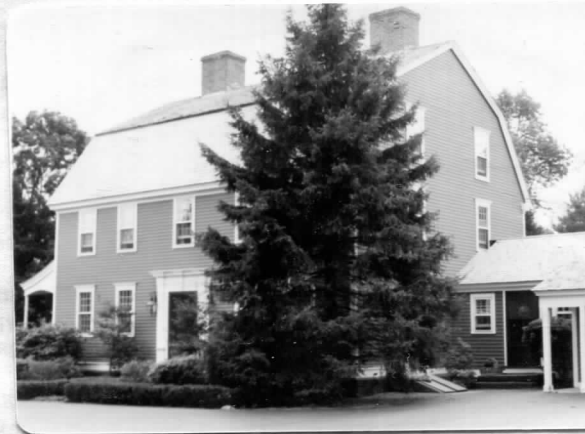
GLFD NEG 4:21A

5. ARCHITECT Rear ell c1660
6. DATE Front gambrel part 1764
- BUILDER Colonial
7. ALTERATIONS  
Side addition connected by a hall; side porch; shed roof addition to the rear ell.
8. NOTABLE FEATURES  
Gambrel roof ell; central hall plan; 12/12 sash; crown mouldings above the window frames; double door; heavily moulded entablature supported by slender fluted pilasters.

9. ARCHITECTURAL-HISTORICAL This house is on The National Register of Historic Places. Even though it was re-erected in Guilford in 1954-55, it is a very fine example of the two-chimney gambrel-roofed Colonial house. Two huge chimneys of hand-made English brick at the ends of a large gambrel roof contribute to the massive look of the house. The rear-ell was the original house. The larger front section, with its gambrel roof, was attached to the ell later. When this was done, part of the ell became the kitchen. The fine doorway has fluted pilasters and an entablature with three advancing panels one over each pilaster and one over the center of the double door.
