HISTORIC RESOURCES INVENTORY - BUILDING AND STRUCTURES

Building Name (Common) 588 Leete's Island Road
 Building Name (Historic) Lawrence R. Leete House
 Street Address or Location 588 Leete's Island Road
 Town/City Guilford Village _____ County New Haven
 Owner(s) Alison L. Page Qualified Pres Res Trust Public Private

Style of building Colonial Revival Date of Construction 1940 (Helander)

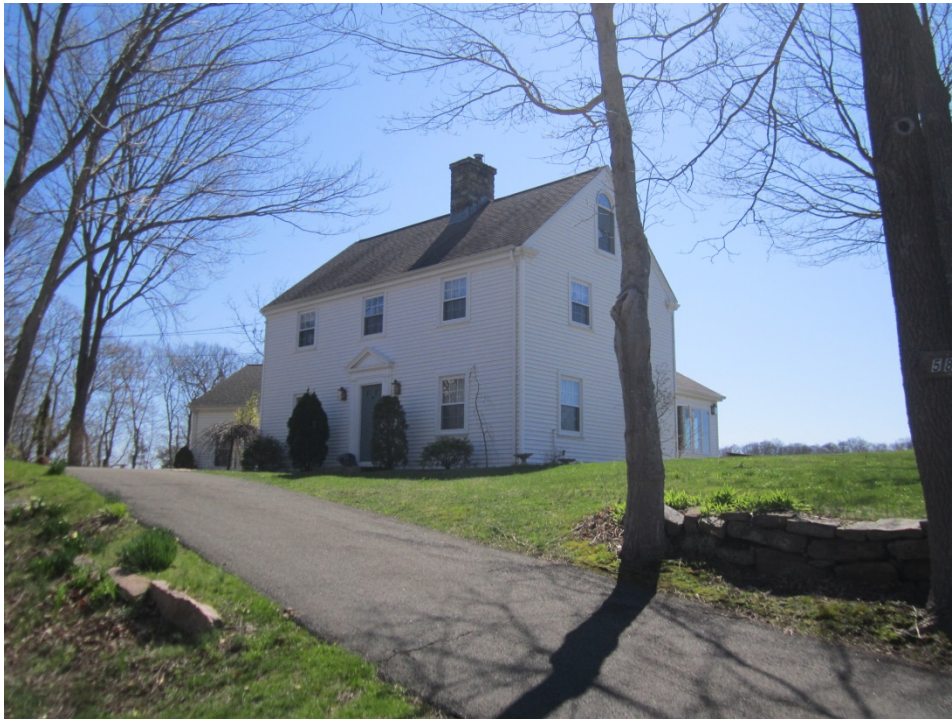
This is a two-story dwelling with an attic and a side-gable roof. The roof is covered in asphalt shingles, and the eaves overhang slightly. The house is Colonial Revival in style and sheathed in vinyl siding. The façade faces north and the main entry is centered on this side. It is reached by way of a stone step and has a decorative door surround with a pediment. (See continuation sheet)

View North view of the house, camera facing south. Negative on File _____

The Colonial Revival features include the symmetrical façade, the decorative door surround with pediment, and the cornice returns on the gable-end of the house. Fenestration consists of six-over-six double hung sash windows. A brick chimney protrudes from the center of the ridgeline of the roof. Additions are on the east and south elevations of the house.
