HISTORIC RESOURCES INVENTORY - BUILDING AND STRUCTURES

Building Name (Common) 1463 Little Meadow Road
 Building Name (Historic) _____
 Street Address or Location 1463 Little Meadow Road
 Town/City Guilford Village _____ County New Haven
 Owner(s) Raymond Martin Public Private

1463 Little Meadow Road

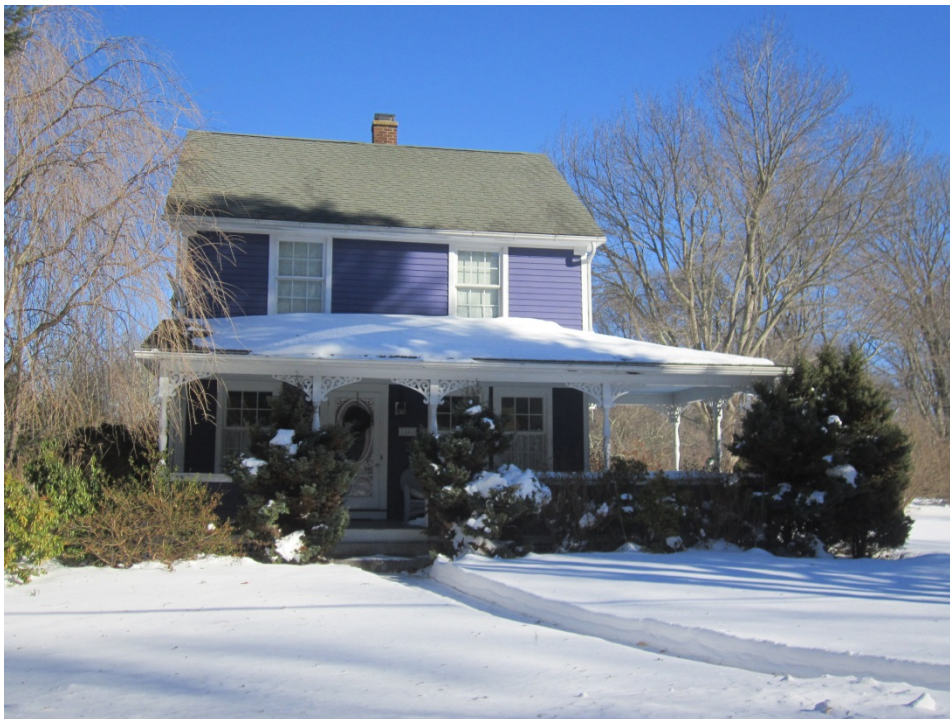
This is a two-story dwelling with an attic and a side-gable roof. The roof is covered in asphalt shingles. The house is vernacular in style and sheathed in clapboard siding. The façade faces west and the main entry is off-center on this side. It is reached by a raised covered porch which extends the full length of the façade and wraps around the southwest corner. (See continuation sheet)

Photographer Kristen Nietering Date 1/31/2015
View West view of the house, camera facing east. Negative on File _____
Name Kristen Nietering Date 11/20/2015
Organization Guilford Preservation Alliance
Address 199 PO Box Guilford, CT 06437

The porch is supported by a series of turned columns with decorative bracketing at the eave line. Fenestration includes six-over-six double-hung windows. A narrow brick chimney is just off-center on the east elevation of the roof. Two full-width additions extend east off the rear elevation of the structure. This vernacular house includes a Victorian Folk style porch; the full width porch with turned spindle supports and lace-like spandrels.
