HISTORIC RESOURCES INVENTORY:
 Buildings & Structures

SURVEY OF GUILFORD, NEW HAVEN COUNTY, 06437
 June-December 1981

1. **ADDRESS** 1261 Long Hill Road
(map 91, lot 51A)
2. **NAME**
 (historic) Nathaniel Stone
NAME
 (common) also "Maple Hill Farm"
3. **USE**
 (historic)
USE
 (present) Private house
4. **IF MOVED, WHEN AND FROM WHERE:**

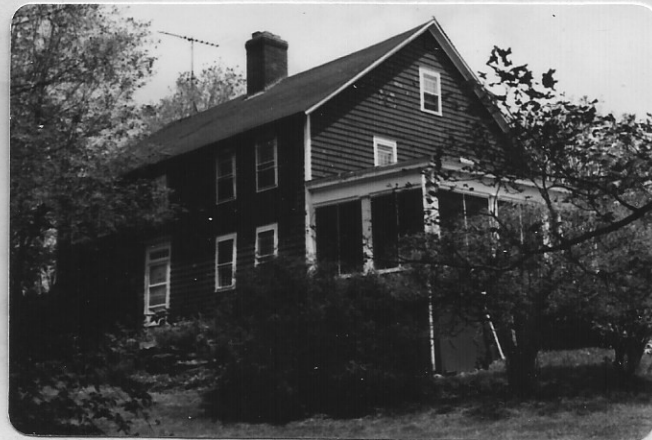
5. **ARCHITECT**
6. **DATE** 1761 **BUILDER**
STYLE Colonial
7. **ALTERATIONS**
 Side addition; shingle siding; new chimney.

8. **NOTABLE FEATURES**
 12/12 sash; 6/6 in the gable; doorway with a six pane transom and a crown moulding.

9. **ARCHITECTURAL-HISTORICAL**
 This house, with its simple transom-lighted doorway and small-paned window sash, retains its Colonial appearance even though its roof now overhangs at the gables. The house is set high above Long Hill Road on the east side, facing west.
 Its original owner, Nathaniel Stone, was a member of the Town committee which purchased kettles for the Town's new salt works in the fall of 1777 - the enterprise failed in December 1777. The Stone family were large land owners in this area.
