**HISTORIC RESOURCES INVENTORY:**  
Buildings & Structures

**SURVEY OF GUILFORD, NEW HAVEN COUNTY, 06437**  
June-December 1981

1. ADDRESS 2131 Long Hill Road  
(map 96, lot 2)
2. NAME  
(historic) H. Elliot  
NAME  
(common)
3. USE  
(historic)  
USE  
(present) Private house
4. IF MOVED, WHEN AND FROM WHERE:

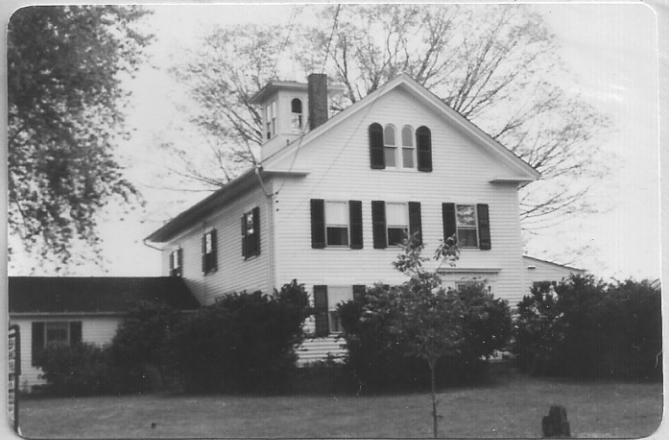
5. ARCHITECT
6. DATE 1850 BUILDER  
STYLE Italianate
7. ALTERATIONS  
Side shed addition; side wing (north); 2/2 sash.

8. NOTABLE FEATURES Boxed cornice with returns; moulding under the eaves; frieze; cupola with wide overhanging eaves; paired arched windows, and a finial; double arched gable windows; wide lintel boards over the windows; double mouldings around the door frame topped with a frieze and cornice; brick foundation.

9. ARCHITECTURAL-HISTORICAL  
The cupola atop this house is its most remarkable feature. Its arched windows and overhanging eaves echo those of the house; it not only unifies the house but reminds us that its builder felt its surrounding of rolling fields were worth more than a casual glance. They still are and so is this house, a very elegant example of the Italianate form and one of the few houses in Guilford with a cupola.  
The H. Elliot<sup>t</sup> (or Elliott) who built this house, may have been a son of the distinguished North Guilford physician, Harvey, a Yale graduate, who died in New York City. Most likely he is none other than the Harvey Elliott of North Guilford who was elected a fence viewer in 1879.
